Addendum 3

RFP State Hall Renovation
dated June 4, 2021

State Hall Renovation Programming Study

Programming Report
October 30 2019

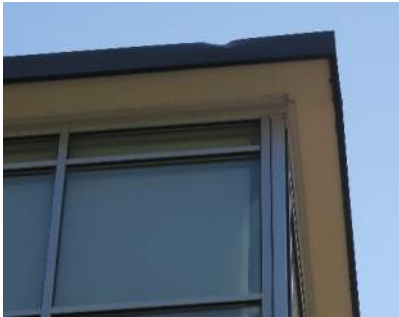
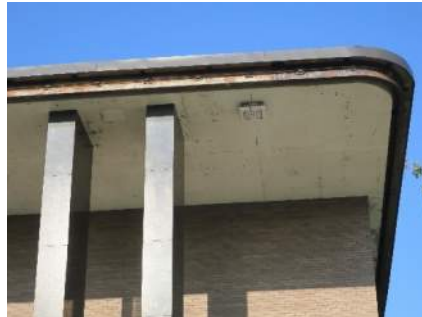
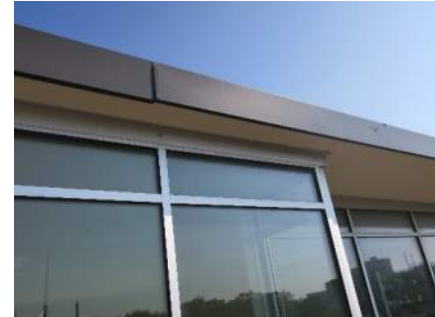
UniFormat Section: B2010 – Exterior Walls
 Location: Entry Canopies, Building Overhangs
 Name: Soffits
 Observation: The soffit area at the main entrance, miscellaneous entrance canopies, and building overhangs appear to be the underside of the cast in-place roof deck. The finish is peeling and heavily stained, presumably from moisture.
 Recommendations: Remove existing finish on underside of all soffits and overhangs around entire building. Prep surface for recoating of new finish.
 Reason for Replacement: Observed moisture infiltration and deferred maintenance
 Priority: Immediate (within 1 to 2 years)

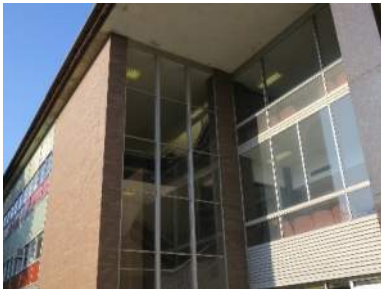
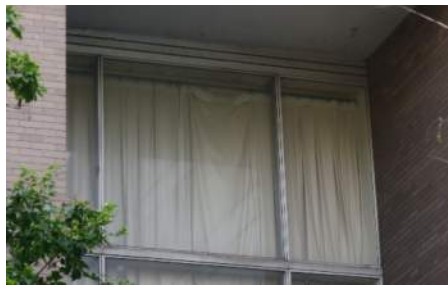
UniFormat Section: B2020 – Exterior Windows
 Location: Entrances and Stair Towers
 Name: Windows
 Observation: Storefronts, windows, and entrances at the main entrance and stair towers appear to be original single pane aluminum, and in some cases original steel sash.
 Recommendations: These are thermally inefficient and do not seal against air infiltration. These should be replaced with insulated glazing in thermal break frames. Assure voids are filled around window perimeter and openings are equipped with through wall flashing.
 Reason for Replacement: Energy Efficiency/Deferred Maintenance
 Priority: Immediate (within 1 to 2 years)

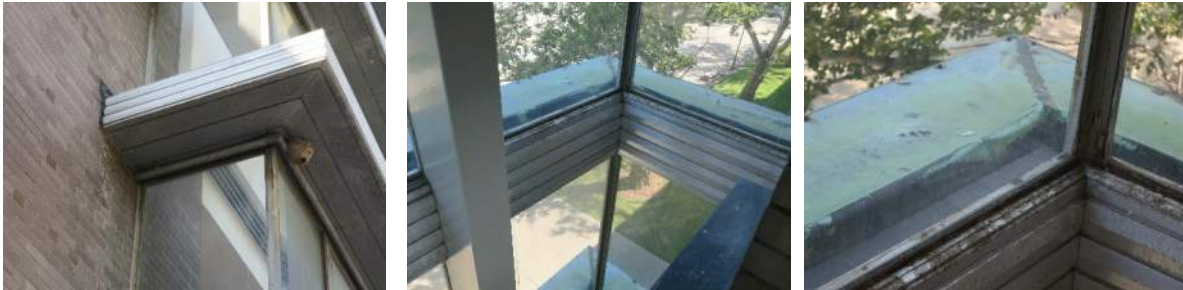
UniFormat Section: B2020 – Exterior Windows
Location: East and West Elevations of 1955 addition
Name: Windows and Metal Panel
Observation: The windows on the east and west elevations of the 1955 addition appear to be original single pane aluminum windows that are glazed with putty. The putty is cracked and falling off in many areas. Many locations air movement could be observed through the joints. The flashing adjacent to these windows is starting to show signs of rust. The horizontal aluminum sills below the windows do not have backer plates. At the metal panels, many of the putty joints are in disrepair and the panels are faded, stained, and the joint seals are deteriorating.
Recommendations: The windows are thermally inefficient and do not seal against air infiltration. These should be replaced with insulated glazing in thermal break frames. Assure voids are filled around window perimeter and openings are equipped with through wall flashing. The aluminum sills below the window should also be removed to allow the addition of appropriate flashing to protect water infiltration of the wall below. The metal panels should be replaced with an ACM metal panel with adequate insulation behind to meet today’s requirements.

Reason for Replacement: Energy Efficiency/Deferred Maintenance
Priority: Immediate (within 1 to 2 years)

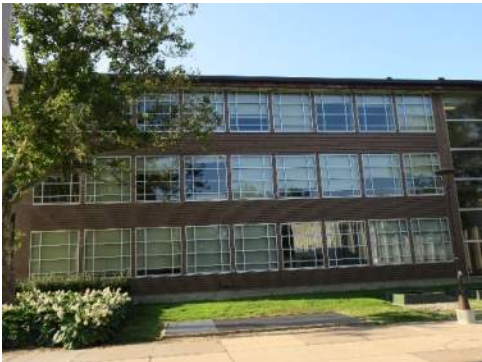
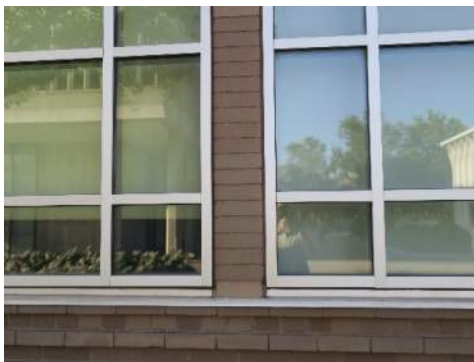
UniFormat Section: B2020 – Exterior Windows
 Location: West Elevations of 1946 Building
 Name: Windows
 Observation: The punched opening windows on the west wall of the original 1945 building addition appear to be the original single pane / steel sash windows.
 Recommendations: The windows are thermally inefficient and do not seal against air infiltration. These should be replaced with insulated glazing in thermal break frames. Assure voids are filled around window perimeter and openings are equipped with through wall flashing.
 Reason for Replacement: Energy efficiency/deferred maintenance
 Priority: Immediate (within 1 to 2 years)

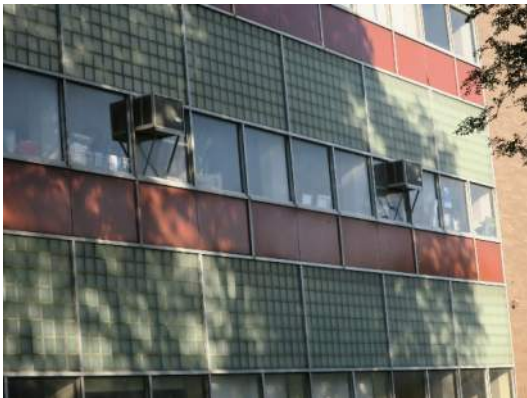
UniFormat Section: B2020 – Exterior Windows
 Location: South and East Elevations of 1946 Building
 Name: Glass Block
 Observation: The glass block on the south and east elevations, above the aluminum windows, are thermally inefficient and outdated. There are individual block pieces in portions of the masonry wall that would remain.
 Recommendations: The windows are thermally inefficient and do not seal against air infiltration. These should be replaced with insulated glazing in thermal break frames or an insulated metal panel system. Assure voids are filled around window perimeter and openings are equipped with through wall flashing. There are some other punched window openings on the north elevation that will remain at this time.
 Reason for Replacement: Energy efficiency, cosmetic, and deferred maintenance
 Priority: Immediate (within 1 to 2 years)

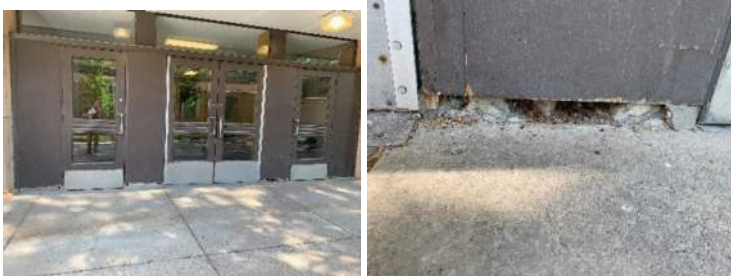
UniFormat Section: B2030 – Exterior Doors
Location: South Entrance of 1946 building
Name: Entrance Doors
Observation: The existing entrance doors and panels adjacent to the doors are deteriorating and have different kinds of hardware on the doors.
Recommendations: Replace the entrance doors with new storefront system along entire width of entry between the stone. Provide ADA accessible push buttons on the new door configuration.
Reason for Replacement: Moisture infiltration, disrepair, damage, and deferred maintenance
Priority: Immediate (within 1-2 years)
