#### Addendum No. 6

#### Student Housing Development Project | Wayne State University

# Section 1: Housing Facilities Assessment and Deferred Maintenance Capital Planning Report (2012 Update)

# Housing Facilities Assessment And Deferred Maintenance Capital Planning Report 2012 Update

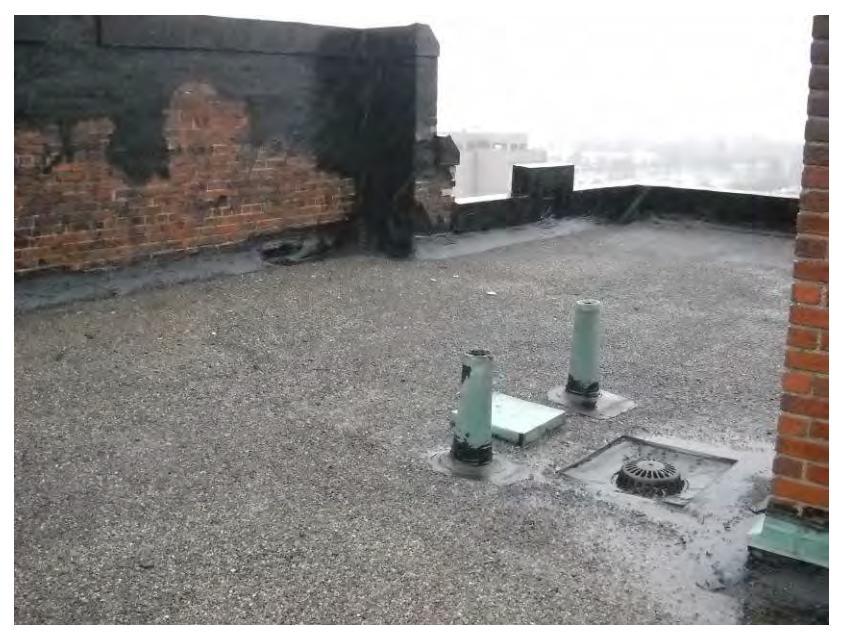
Roofing system is at the end of its useful life

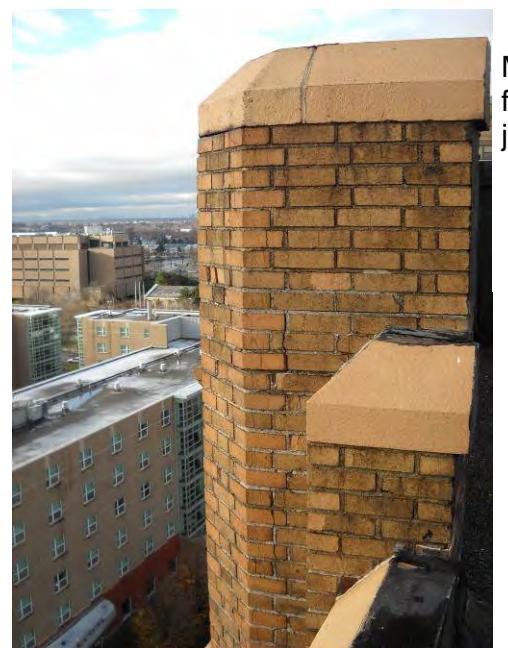
Majority of the masonry façade requires mortar joint tuck-pointing.

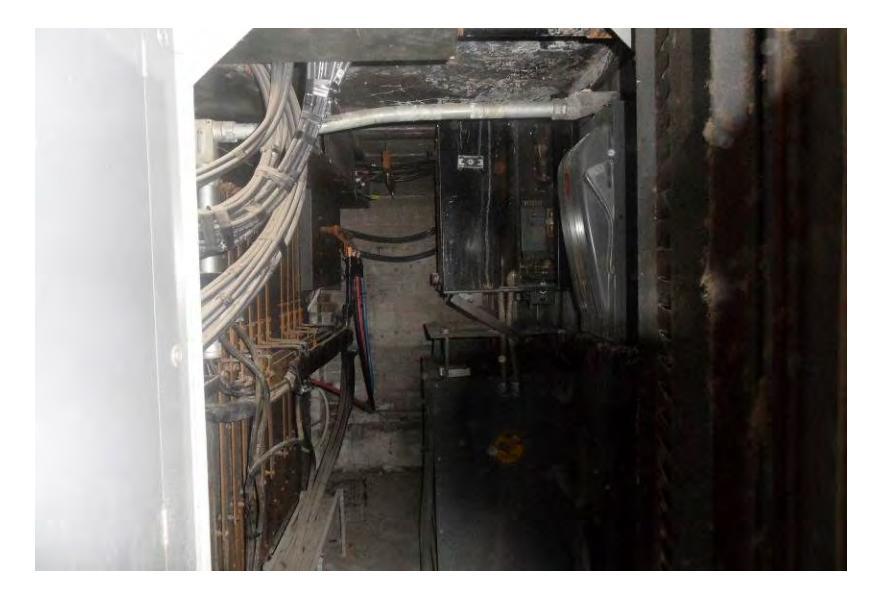
Open bussing in main switchboard presents a shock hazard to personnel and does not meet clearance requirements.

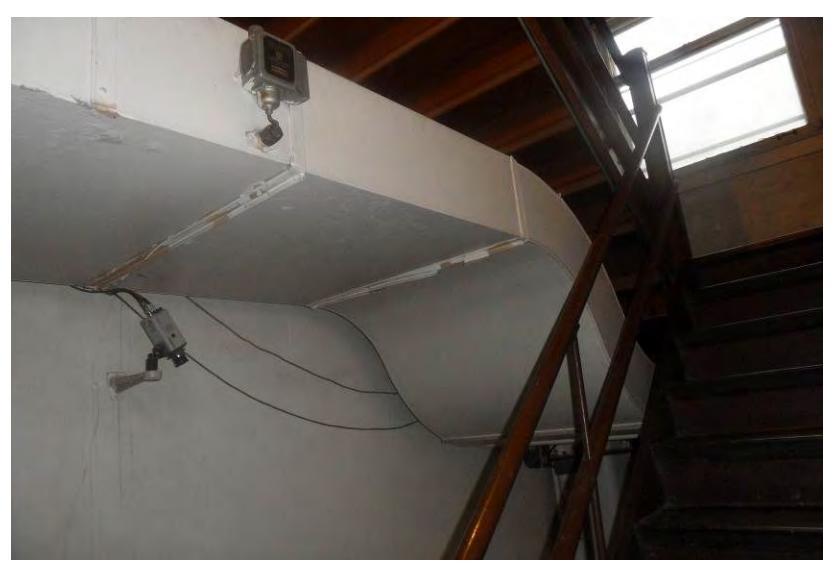
Supply air units in stairways are failing and beyond useful service life.

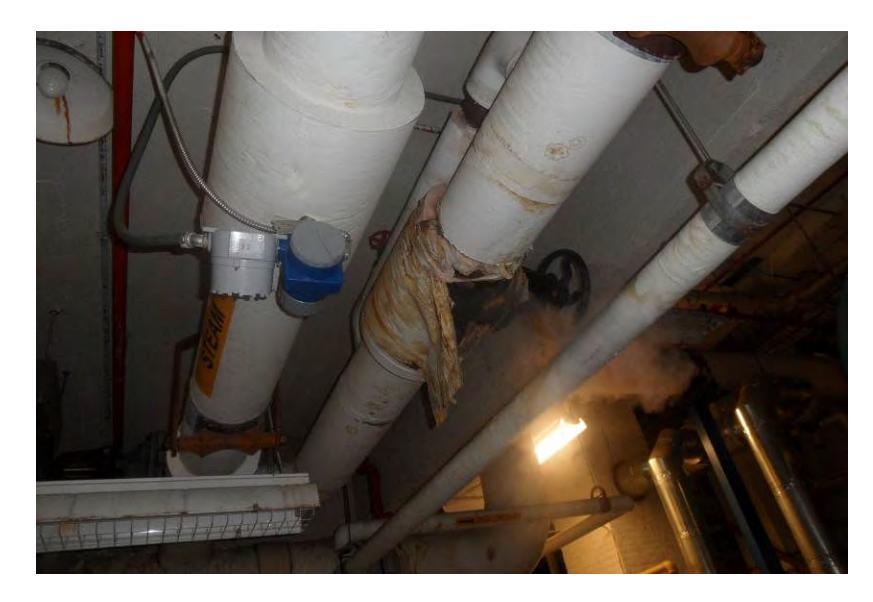
Leaking steam pipes are damaging insulation and surrounding items.

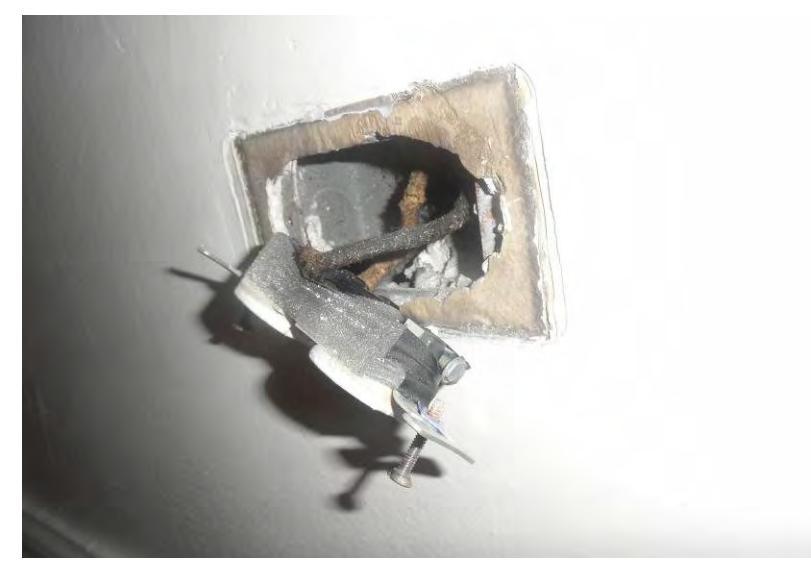
Replaced receptacles do not have ground wires tied to the ground slot.

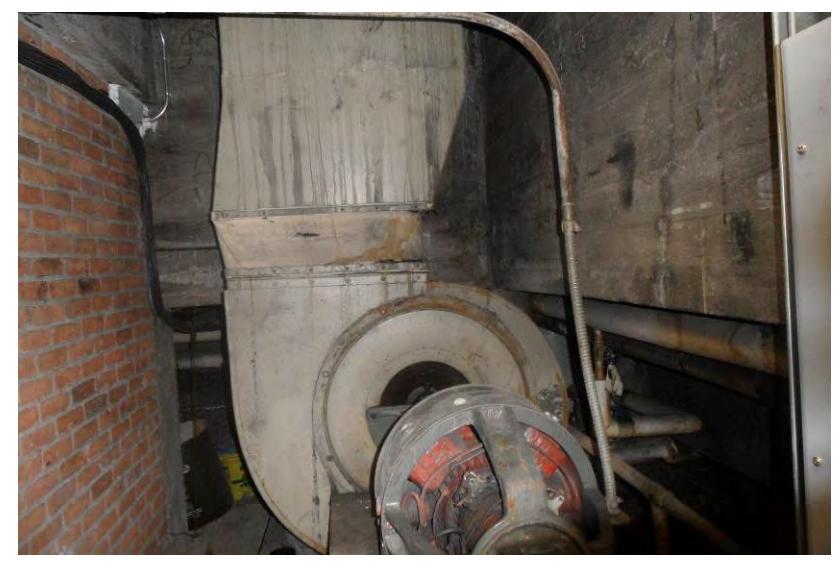
Exhaust fan in the attic is failed and beyond its useful service life.

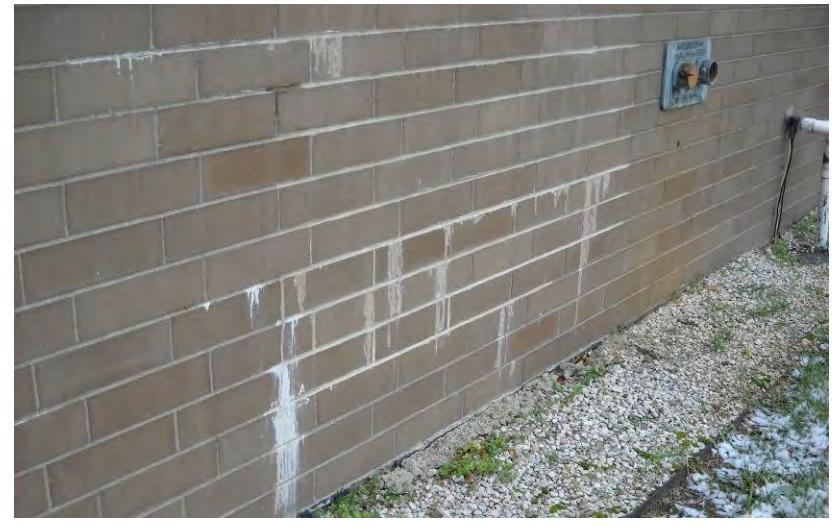
Evidence of water infiltration

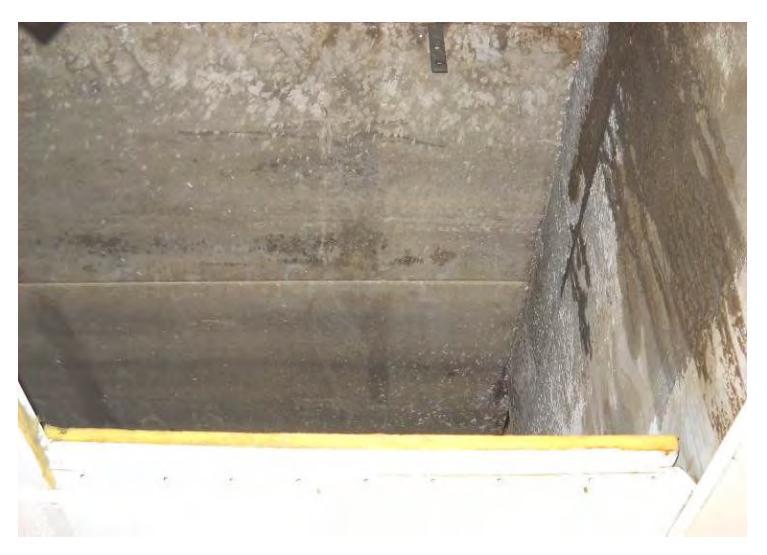
Evidence of water infiltration

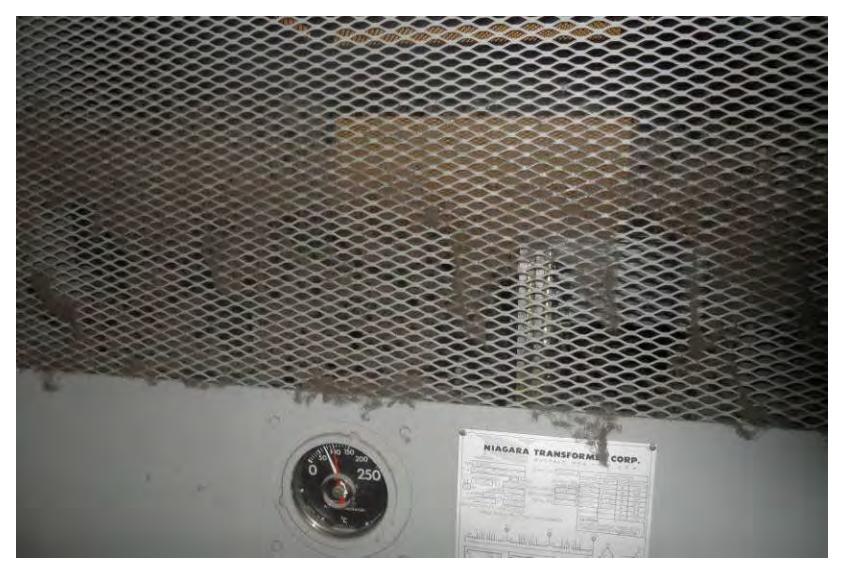
Transformer housing requires periodic cleaning.

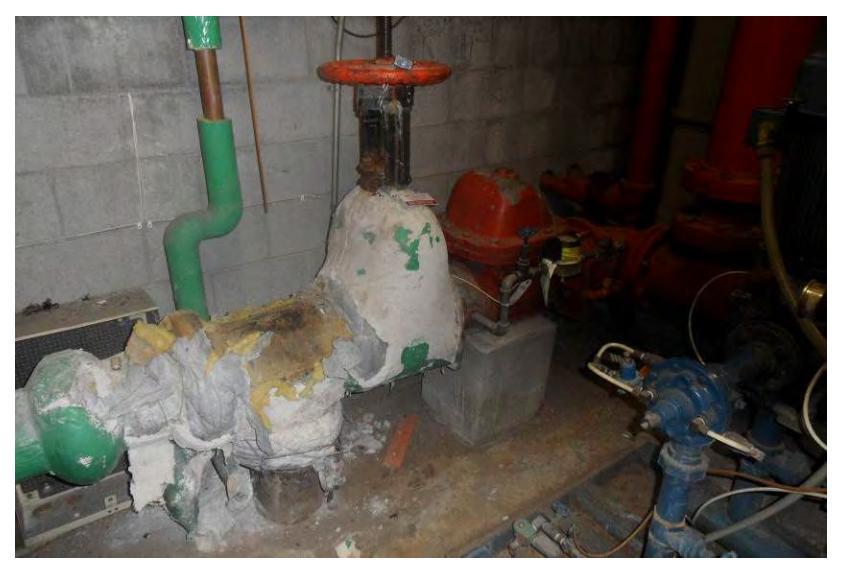
Pipe insulation failing on the water main.

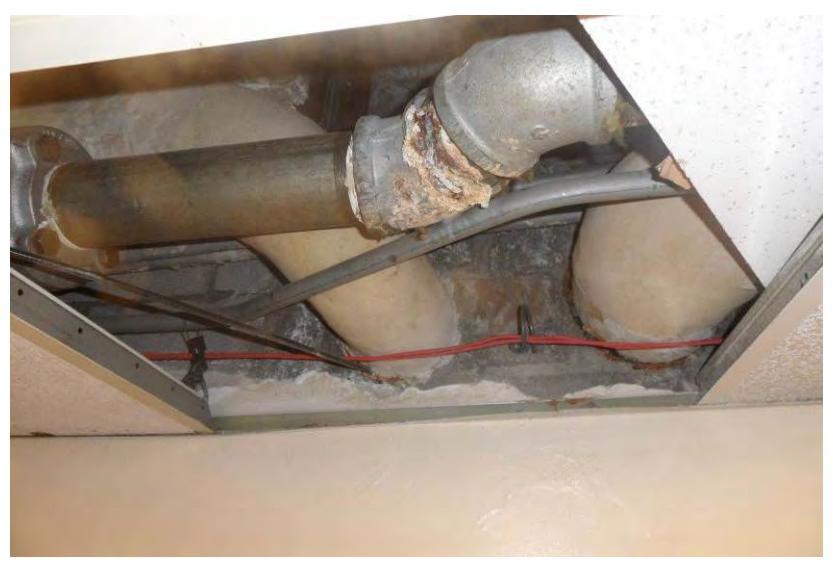
Galvanized pipe connections starting to fail and leak.

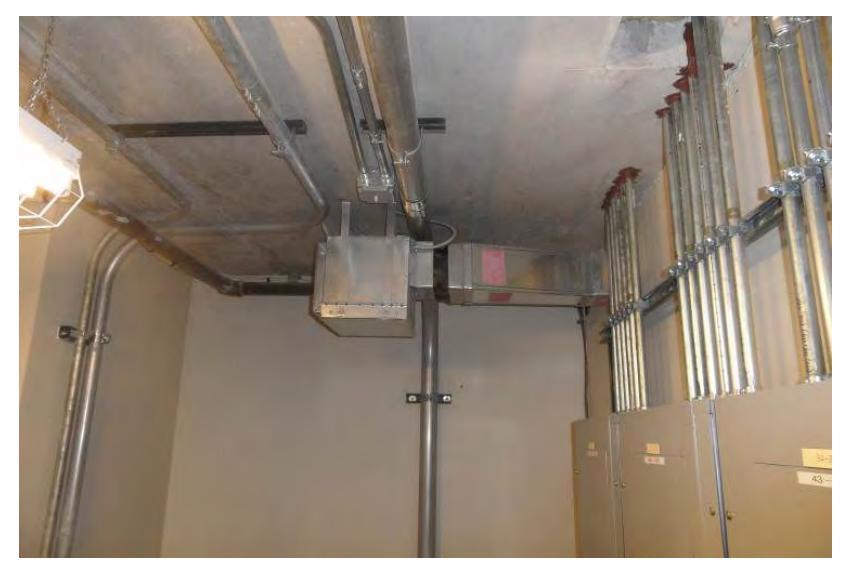
Exhaust fan from Electrical Room into Storage Room may be too small. Electrical Room is too warm.

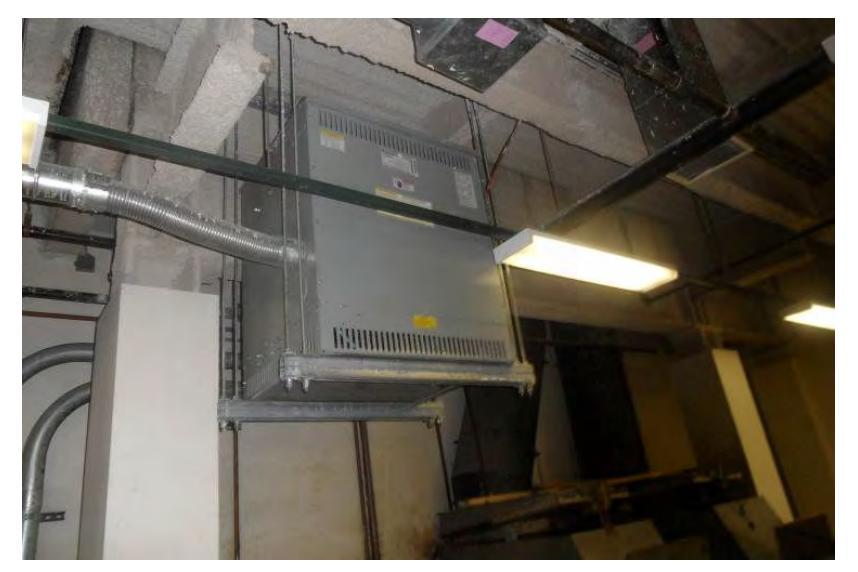
Open, dry-type, electrical transformer in Waste Area susceptible to water spray.

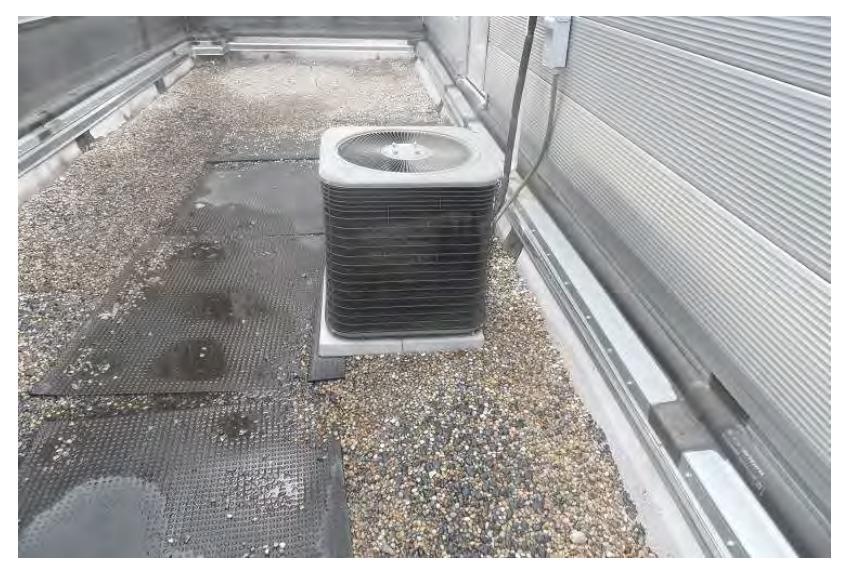
Elevator room air conditioning unit condenser requires coil cleaning.

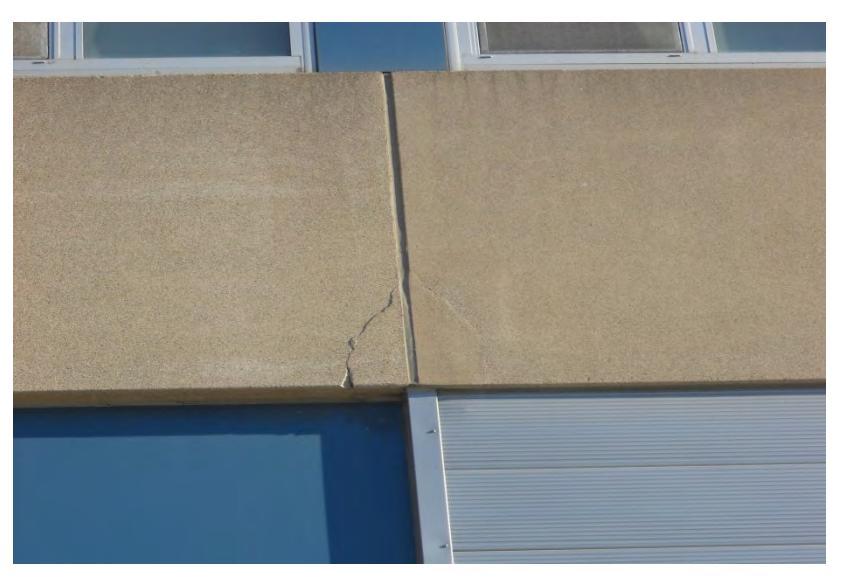
Minor cracking in precast concrete panels – clean crack and seal

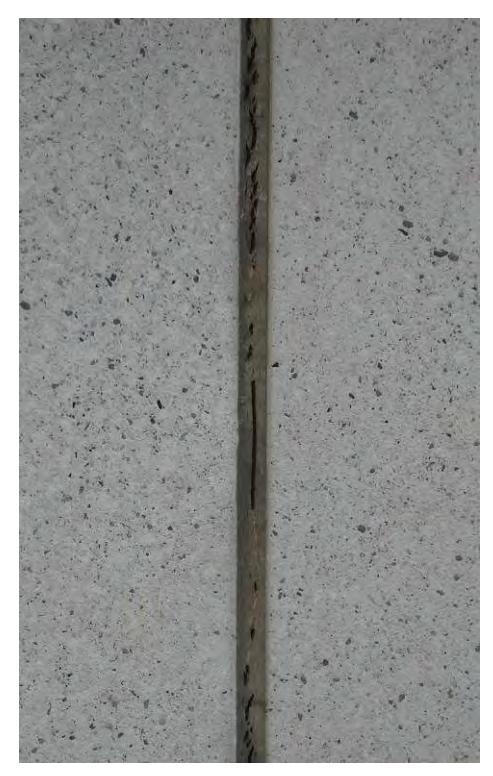
Failing sealant.

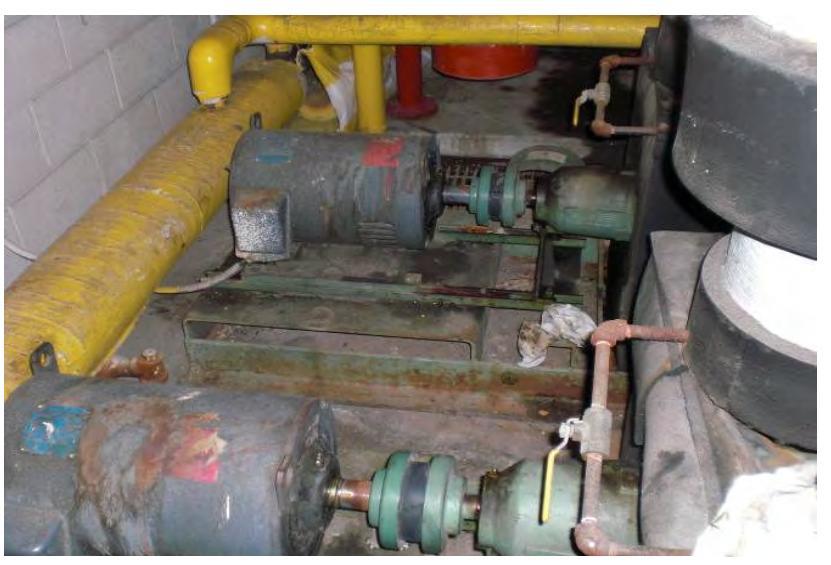
Heating hot water circulating pump motors at end of useful service life.

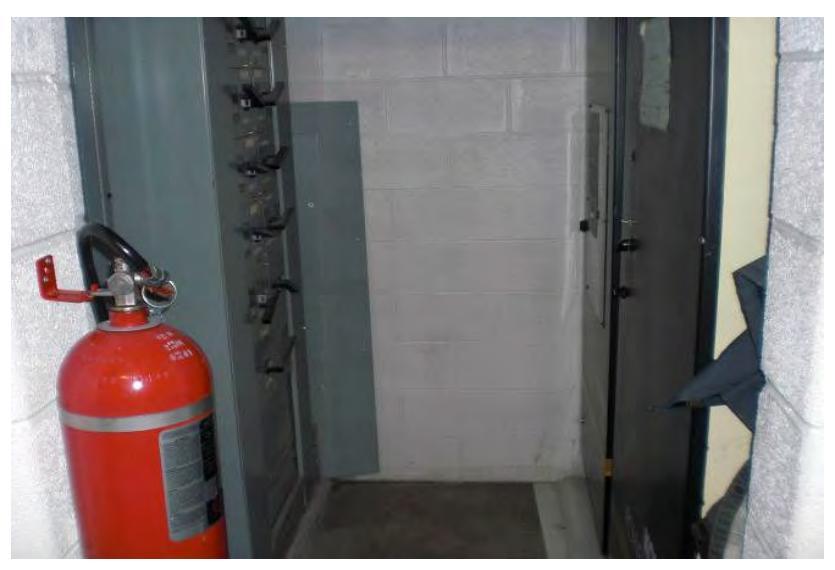
Transfer switch/panelboard inter-panel clearance may be service issue.

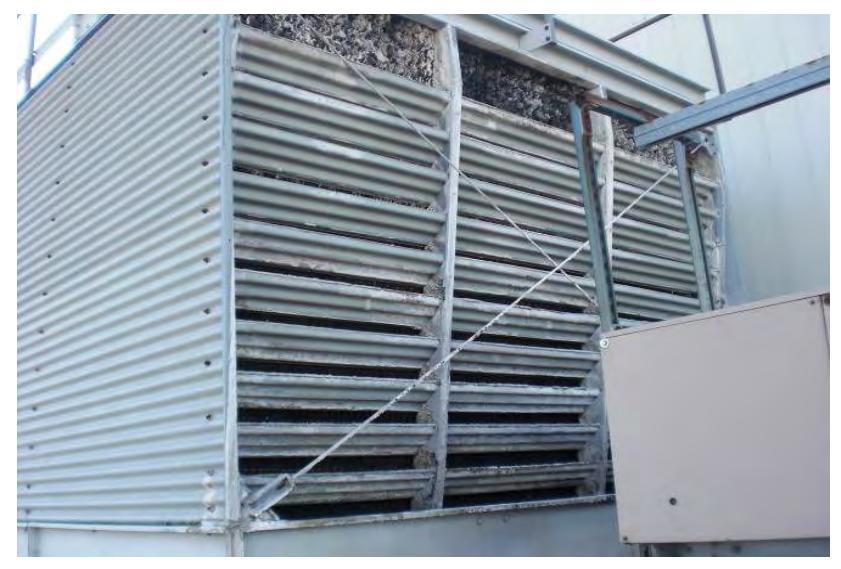
Cooling tower fill is in poor condition and requires replacement.

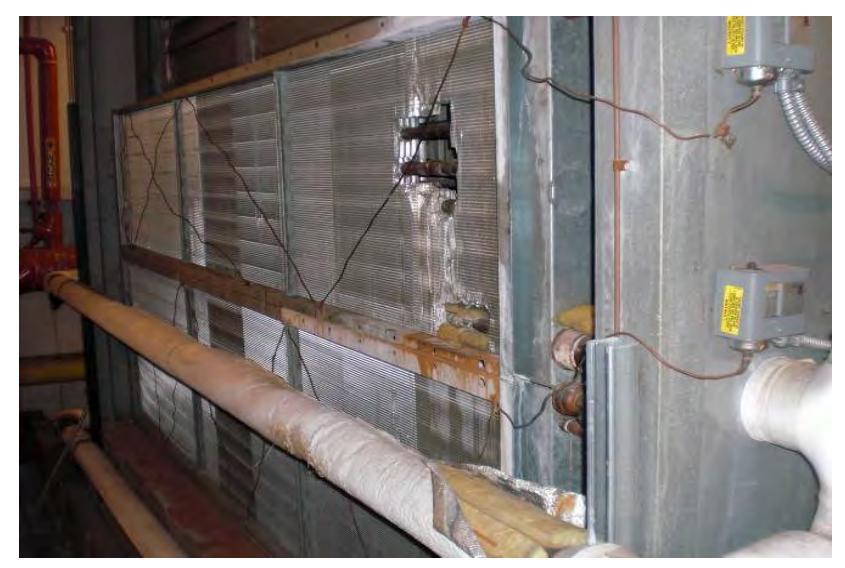
Make-up Air Handler unit coil is not operational.

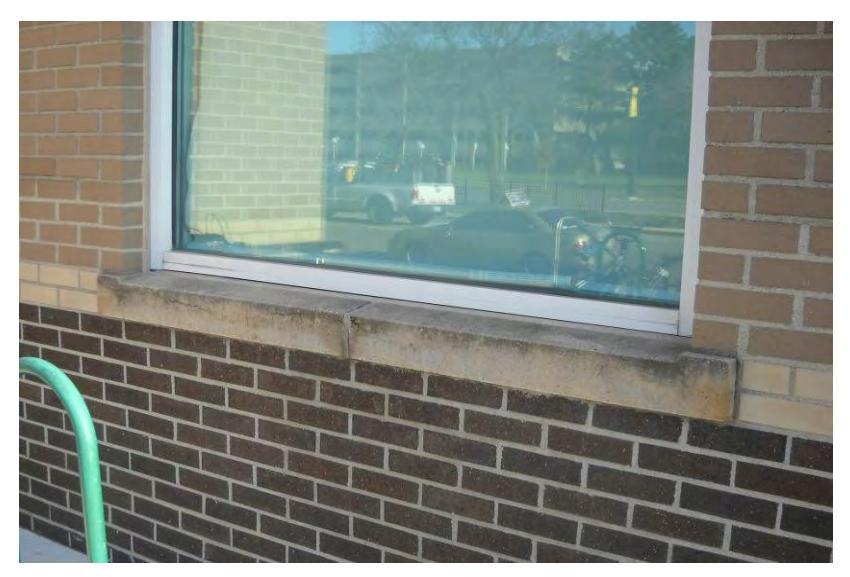
Windowsills with excessive staining suggest water management concerns and probable deterioration.

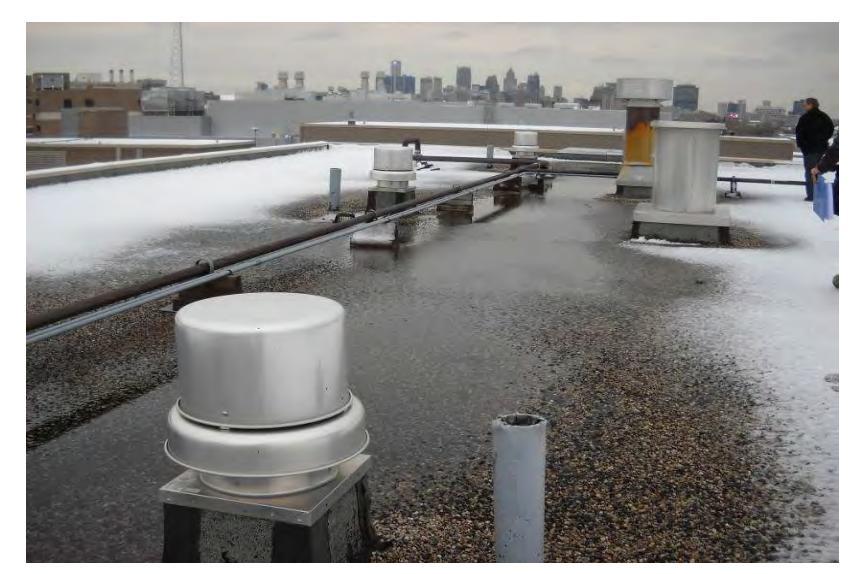
Roof slope does not allow for adequate drainage. Ponding is causing leaks inside building.

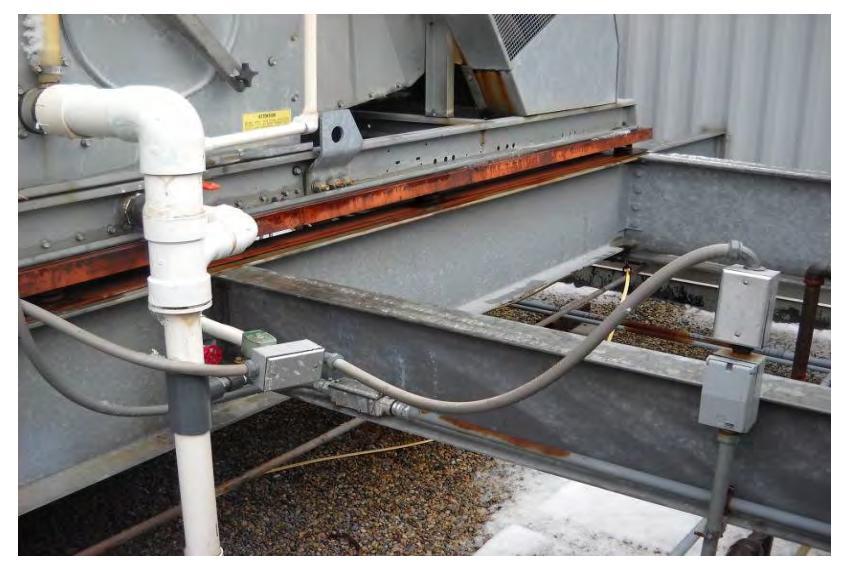
Heat trace cabling and power supply is not properly attached.

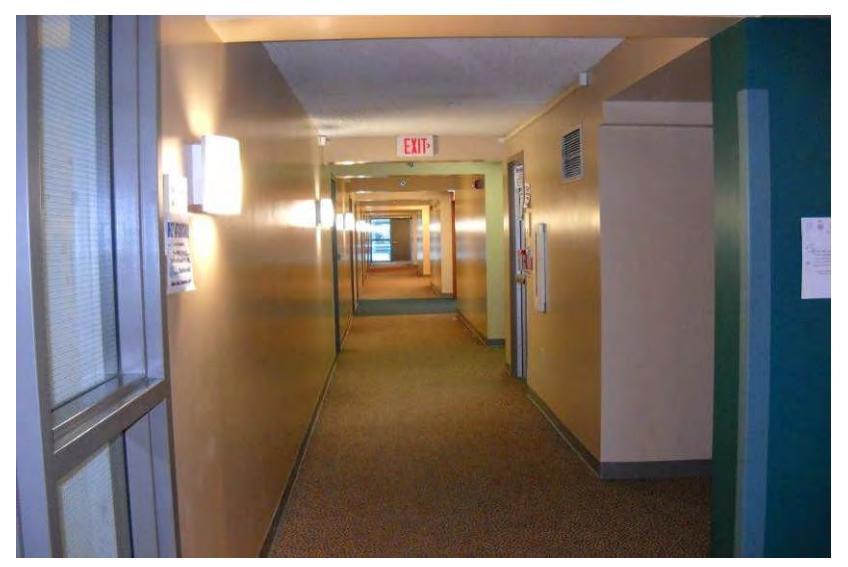
Exit signs at end of corridor are difficult to see; do not show path of egress.

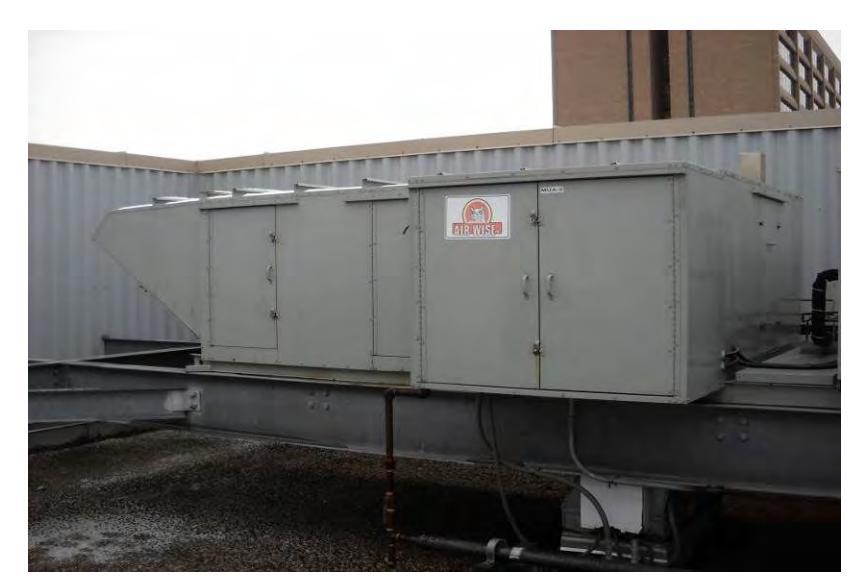
Elevated rooftop equipment is too high to step over the steel framing and flue extensions are not extended to parapet elevation causing re-entrainment issue.

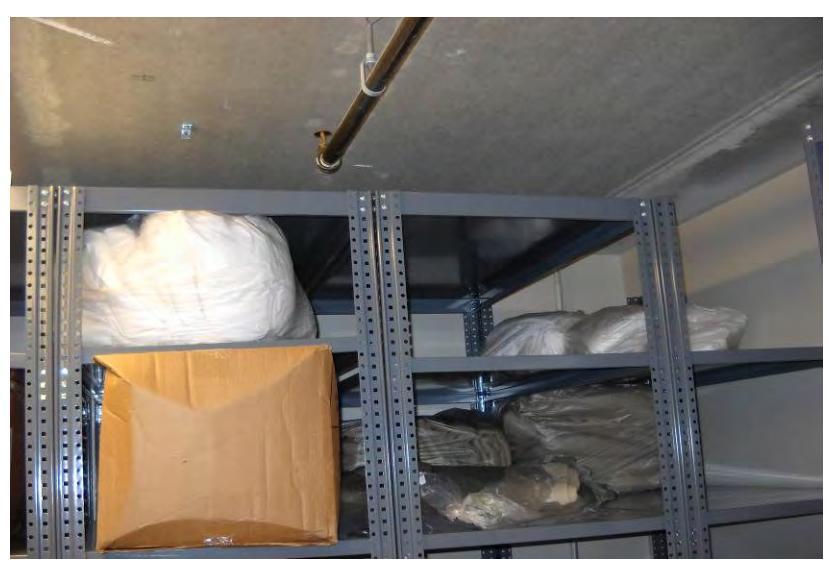
Stored items are too close to sprinkler head. Per code, 18 inches clear space is required.

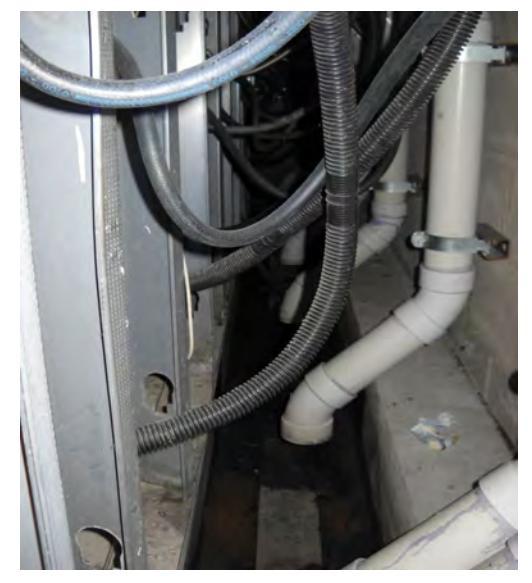
Washing machines discharge into open trench causing significant odor issue.

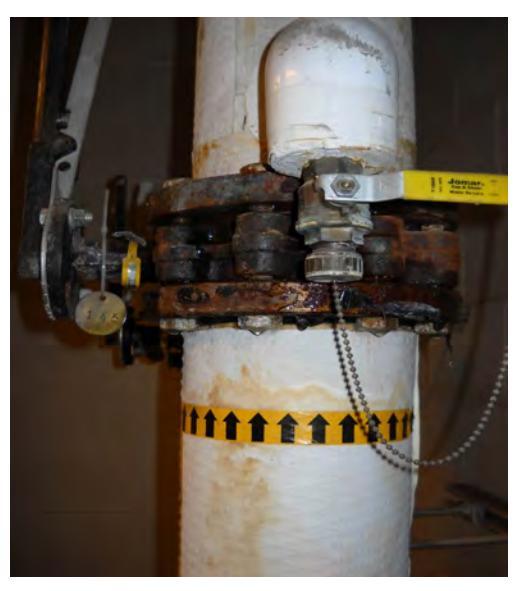
Heating water loop isolation valve is leaking.

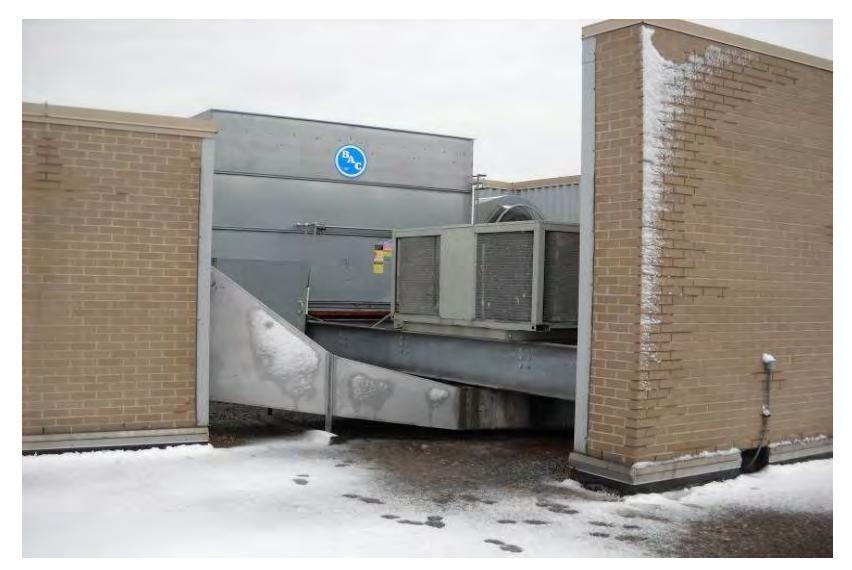
Need to step on ductwork to access the other side of the unit.

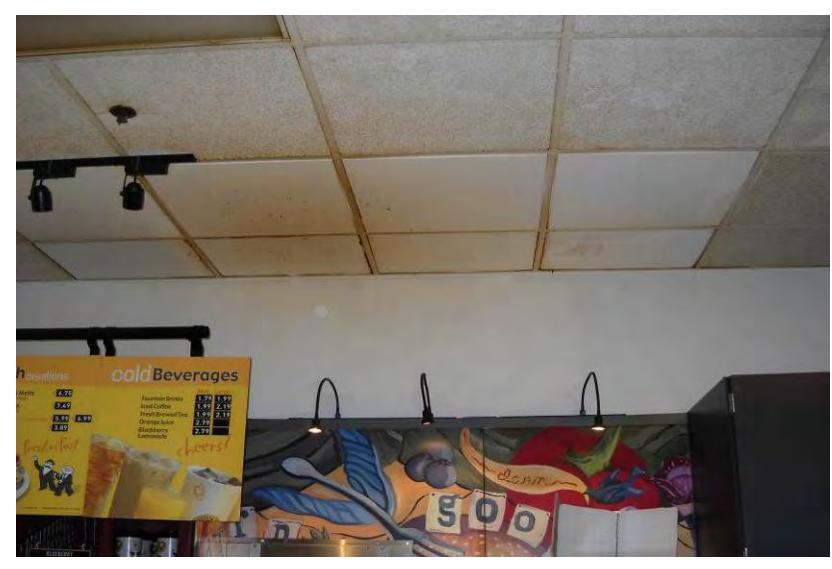
Ceilings damaged from heat buildup.

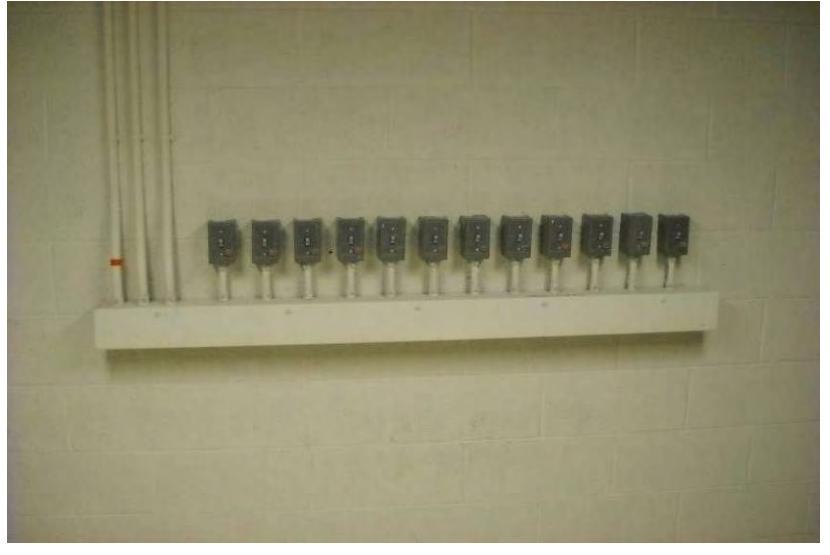
Disconnect switches for roof-mounted exhaust fans are not in line-of-site of the equipment and violate code. They also cannot use lock-out/tag out products for safe maintenance

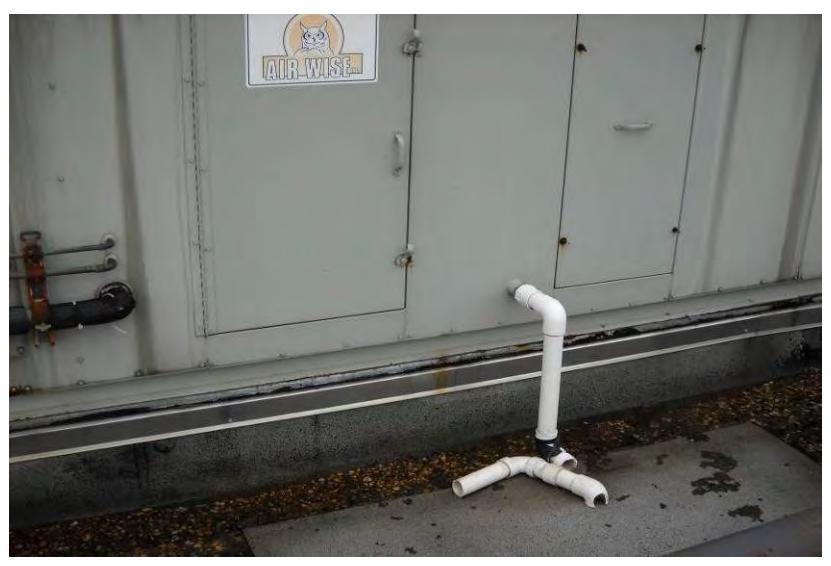
PVC condensate drain pan traps are broken due to UV breakdown or stepping on.

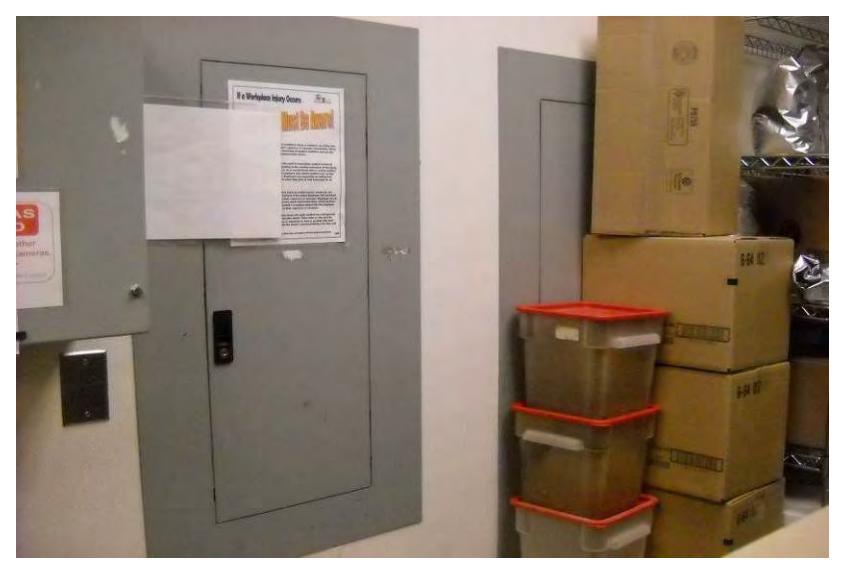
Panelboards are obstructed in Tenant Fit-out Area.

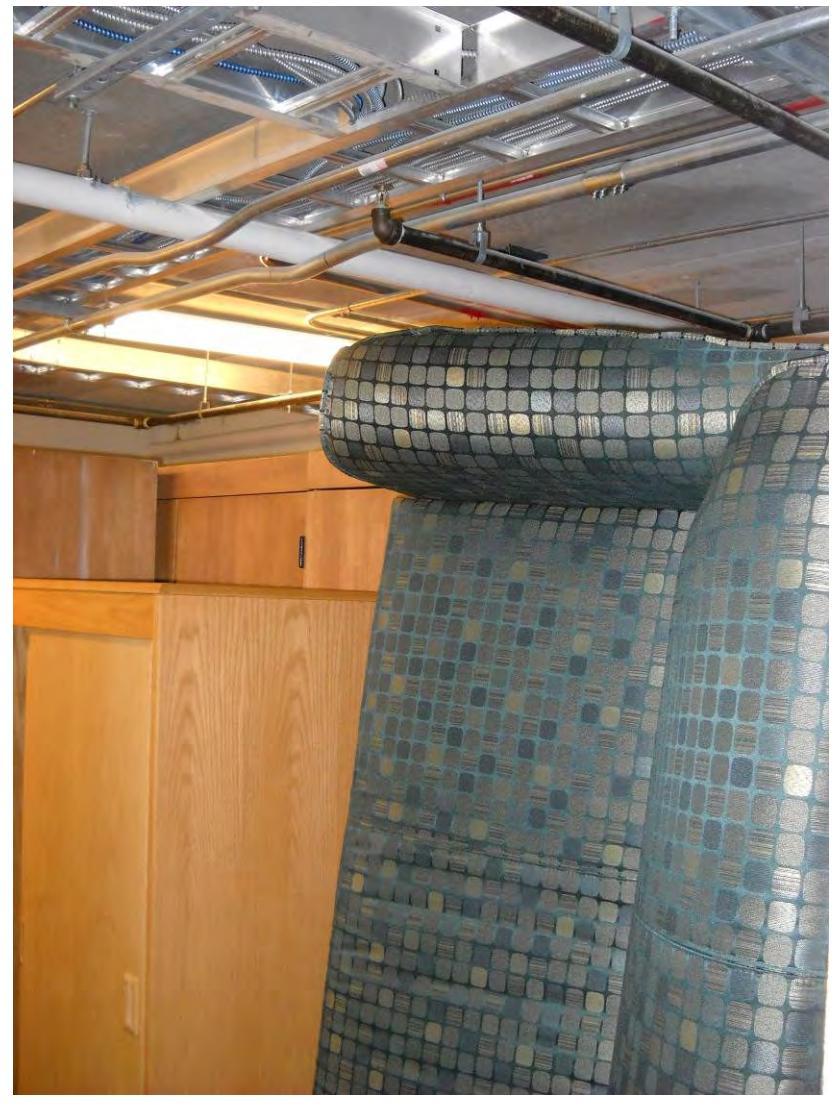
Stored materials are too close to fire suppression sprinkler heads. 18 inches of clear space is required by code.

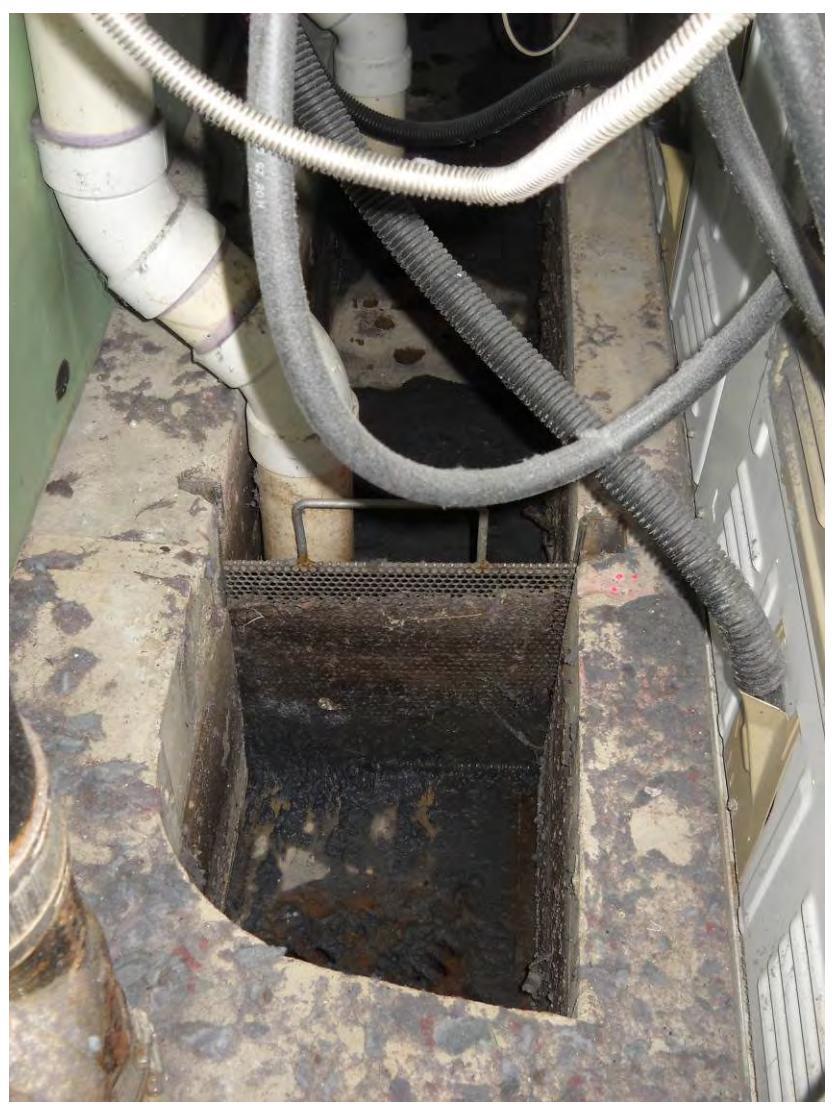
Washing machines discharge into open trench causing significant odor issue.
