Addendum 3

RFP State Hall Renovation
dated June 4, 2021

State Hall Renovation Programming Study

Programming Report
October 30 2019

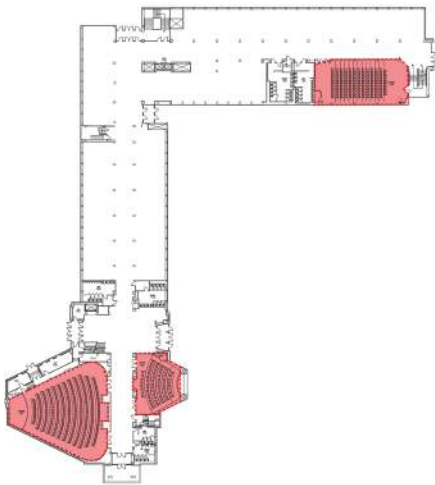
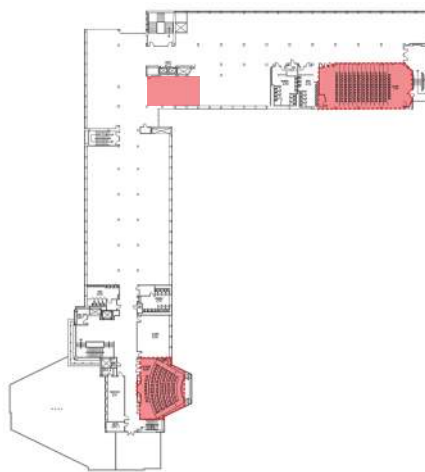
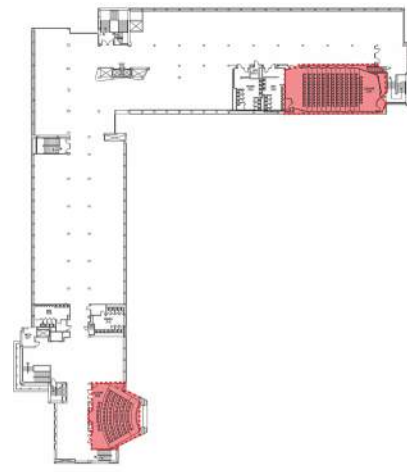
Figure 33

In order to make the lecture halls ADA compliant, the rooms highlighted in red below may need to be structurally modified in order to create an appropriate slope condition or support for an accessible wheelchair lift.

Renovations to the building shall ensure that the structural integrity of the building and its components are maintained. In particular, a structural assessment and analysis of the existing tiered classroom slabs and supports may be necessary when the ADA accommodations are determined, and if it is determined that weight will be added. To minimize the addition of weight, such as lightweight concrete, or the use of products such as USG Structural Panels over cold-formed steel framing, may be required. If an assessment of the existing concrete structure indicates that the structure may be overloaded, reinforce the structure with carbon fiber reinforced polymers.

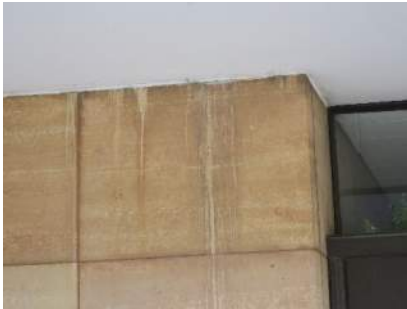
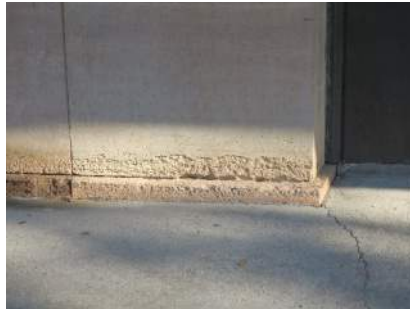
UniFormat Section: B2010 – Exterior Walls
Location: North and West Entrances
Name: Stone Base
Observation: Near the north and west entrance of the 1946 building, the stone base below masonry is deteriorating from salt, is stained, and appears to have significant water infiltration near the top from the canopy above.
Recommendations: Remove lower pieces of stone all along entrance. Remove stone curb below. Replace with new concrete or stone base 8” high above concrete slab that is resistant to salt and other elements.
Reason for Replacement: Moisture infiltration, disrepair, damage, and deferred maintenance
Priority: Immediate

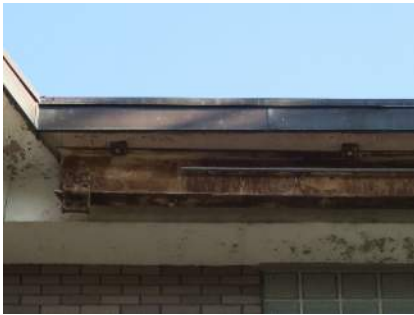
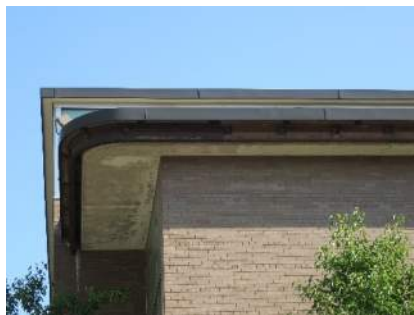
UniFormat Section: B2010 – Exterior Walls
 Location: Roof Overhang along Perimeter of Building
 Name: Steel Window Washing Rail
 Observation: The exposed steel window washing monorail on the south, east, and north elevations is heavily rusted and does not appear to be in use.
 Recommendations: It is recommended that this rail be removed, and the concrete soffit be patched and refinished.
 Reason for Replacement: Age and useful life
 Priority: Immediate

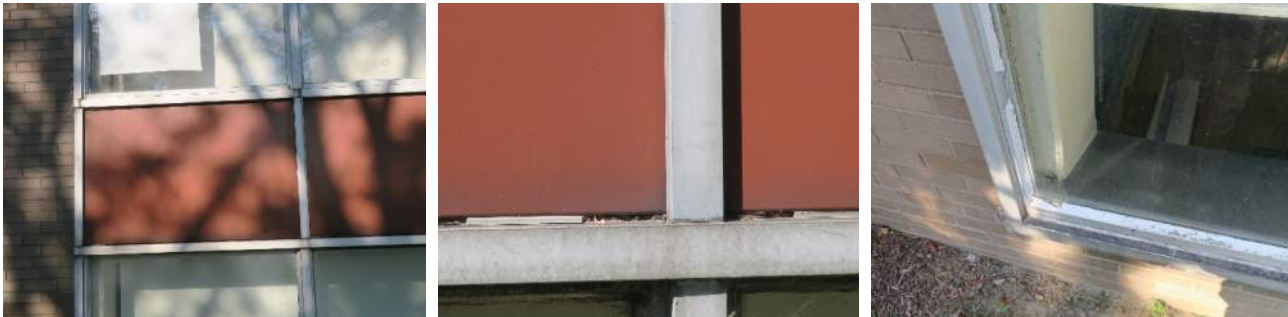
UniFormat Section: B2020 – Exterior Windows
Location: East and West Elevations of 1955 addition
Name: Windows and Metal Panel
Observation: The windows on the east and west elevations of the 1955 addition appear to be original single pane aluminum windows that are glazed with putty. The putty is cracked and falling off in many areas. Many locations air movement could be observed through the joints. The flashing adjacent to these windows is starting to show signs of rust. The horizontal aluminum sills below the windows do not have backer plates. At the metal panels, many of the putty joints are in disrepair and the panels are faded, stained, and the joint seals are deteriorating.
Recommendations: The windows are thermally inefficient and do not seal against air infiltration. These should be replaced with insulated glazing in thermal break frames. Assure voids are filled around window perimeter and openings are equipped with through wall flashing. The aluminum sills below the window should also be removed to allow the addition of appropriate flashing to protect water infiltration of the wall below. The metal panels should be replaced with an ACM metal panel with adequate insulation behind to meet today’s requirements.

Reason for Replacement: Energy Efficiency/Deferred Maintenance
Priority: Immediate (within 1 to 2 years)

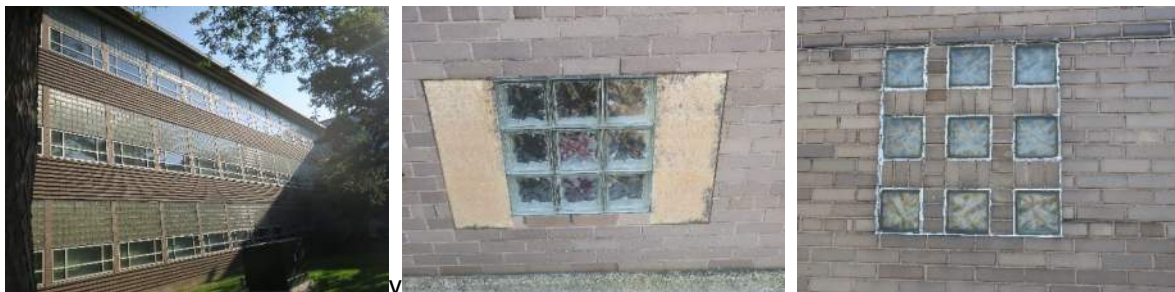
UniFormat Section: B2020 – Exterior Windows
 Location: South and East Elevations of 1946 Building
 Name: Glass Block
 Observation: The glass block on the south and east elevations, above the aluminum windows, are thermally inefficient and outdated. There are individual block pieces in portions of the masonry wall that would remain.
 Recommendations: The windows are thermally inefficient and do not seal against air infiltration. These should be replaced with insulated glazing in thermal break frames or an insulated metal panel system. Assure voids are filled around window perimeter and openings are equipped with through wall flashing. There are some other punched window openings on the north elevation that will remain at this time.
 Reason for Replacement: Energy efficiency, cosmetic, and deferred maintenance
 Priority: Immediate (within 1 to 2 years)
