#### Addendum No. 6

#### Student Housing Development Project | Wayne State University

# Section 1: Housing Facilities Assessment and Deferred Maintenance Capital Planning Report (2012 Update)

# Housing Facilities Assessment And Deferred Maintenance Capital Planning Report 2012 Update

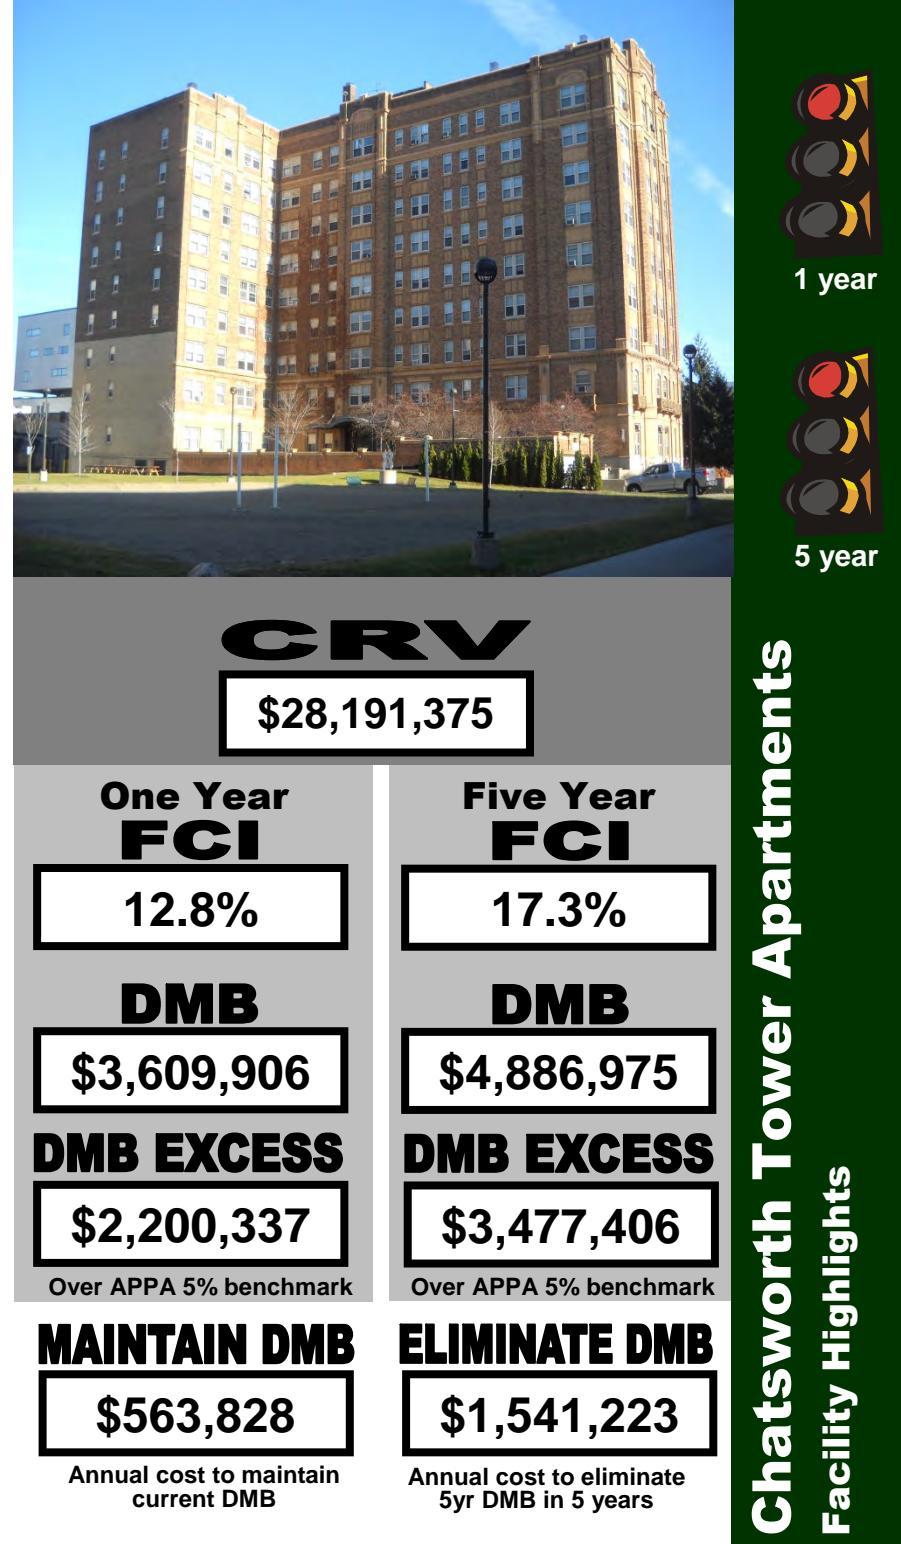
- Listed on the National Register of Historic Places.
- Code related issues such as: non-rated door assemblies at dwelling units, non-rated door assemblies at egress stairs, configuration / obstructions at egress stairs, and dead end corridors, require immediate resolution.
- Built-up roofing systems, including flashings, are at the end of their useful service life, replacing the system in its entirety is recommended.
- The glazing system is at the end of its useful service life, replacing the system in its entirety is recommended.
- In various areas, the masonry façade (clay brick, terra cotta, decorative tile, and limestone shapes) requires mortar joint tuck-pointing.
- In various areas of the masonry façade, clay brick units, terra cotta shapes, and limestone shapes are deteriorated, replace the deteriorated units.

- Building sealant joints are at the end of their useful service life, remove and replace the system in its entirety.
- Corridor supply air fans and coils have failed and should be replaced.

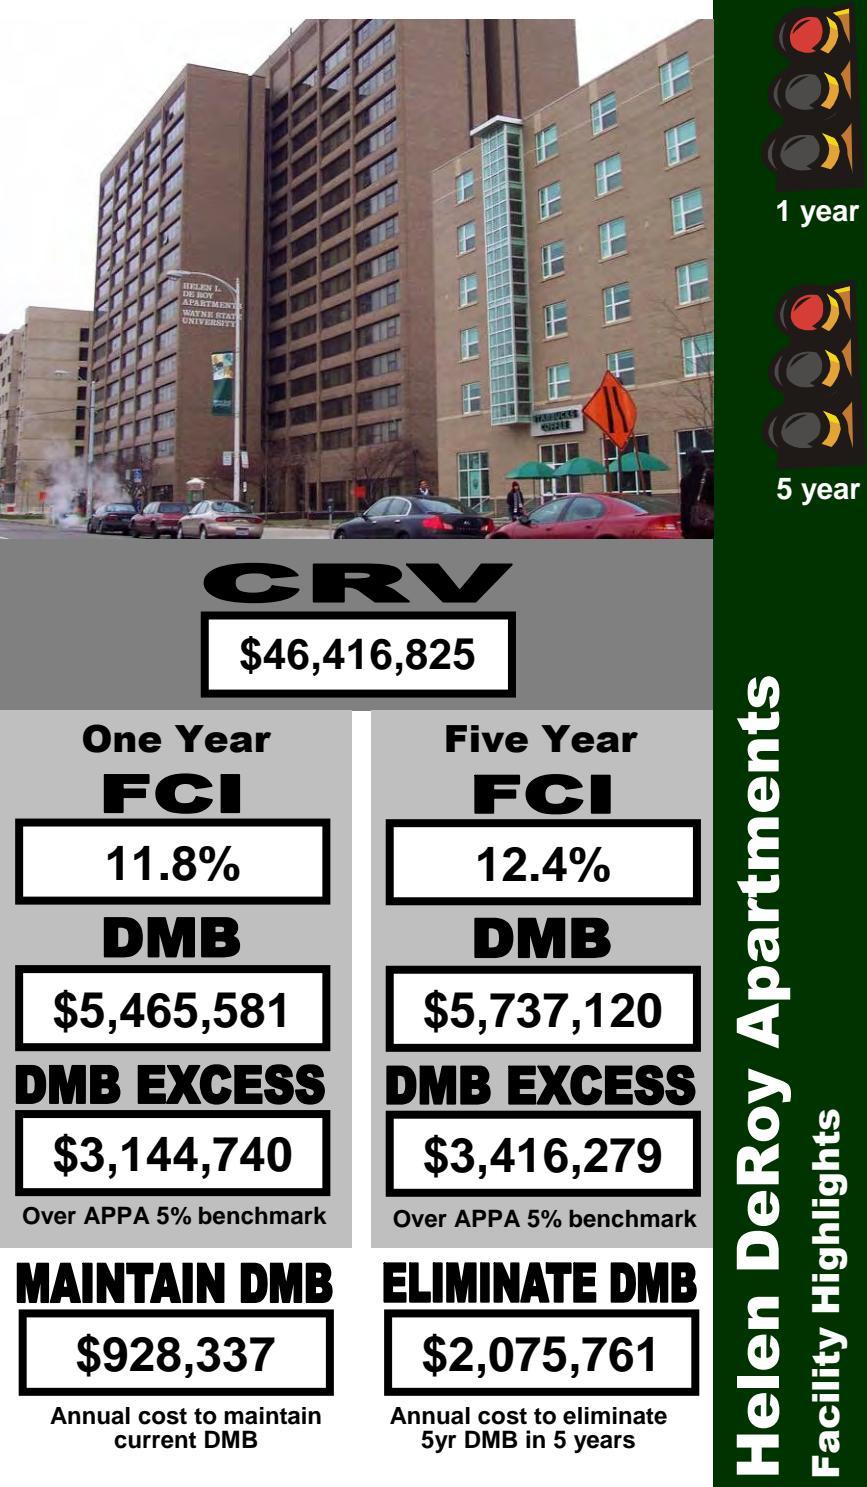
- The windows are apparently not leaking. Leaks & air infiltration at perimeter & window heads is an ongoing problem.
- Exterior precast brick clad concrete panels, reinforcing corroding brick cracking 10-15% per year. Movement in horizontal brick panels. Panel problems appear to be responsible for water infiltration.
- Water infiltration damage is evident at ceilings adjacent to window in every apartment and should be inspected. Exterior precast brick clad concrete panels and aluminum framed casement windows appear to be contributing to this issue. Further investigation and replacement of these systems may not be required.

- Original apartment kitchen cabinets are dated and showing significant wear – 10% per year replacement beginning 2004.
- Exterior hollow metal stairwell doors panic bars, jambs & doors in poor condition need replacement.
- Corridor carpet shows wear, due for replacement soon.
- Circuit breakers in apartments need testing and exercising. GFCI's are needed for safety at sinks.
- Penthouse Make-up Air Handler dampers and coil are not operational and need repair.
- Galvanized water piping is starting to leak at joints.
- Domestic water booster needs repair/replacement.
- Main electrical transformer housing requires periodic cleaning.
- No standby emergency power is provided for the building.
- Fire suppression system in mechanical room, lobby only not in apartments.
- Fire alarm: Simplex pull stations, strobes & horns tied to public safety.

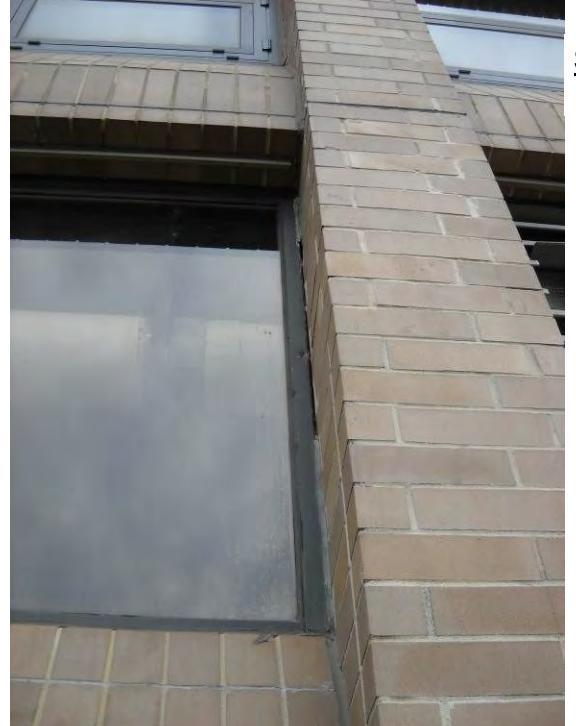
Evidence of water infiltration

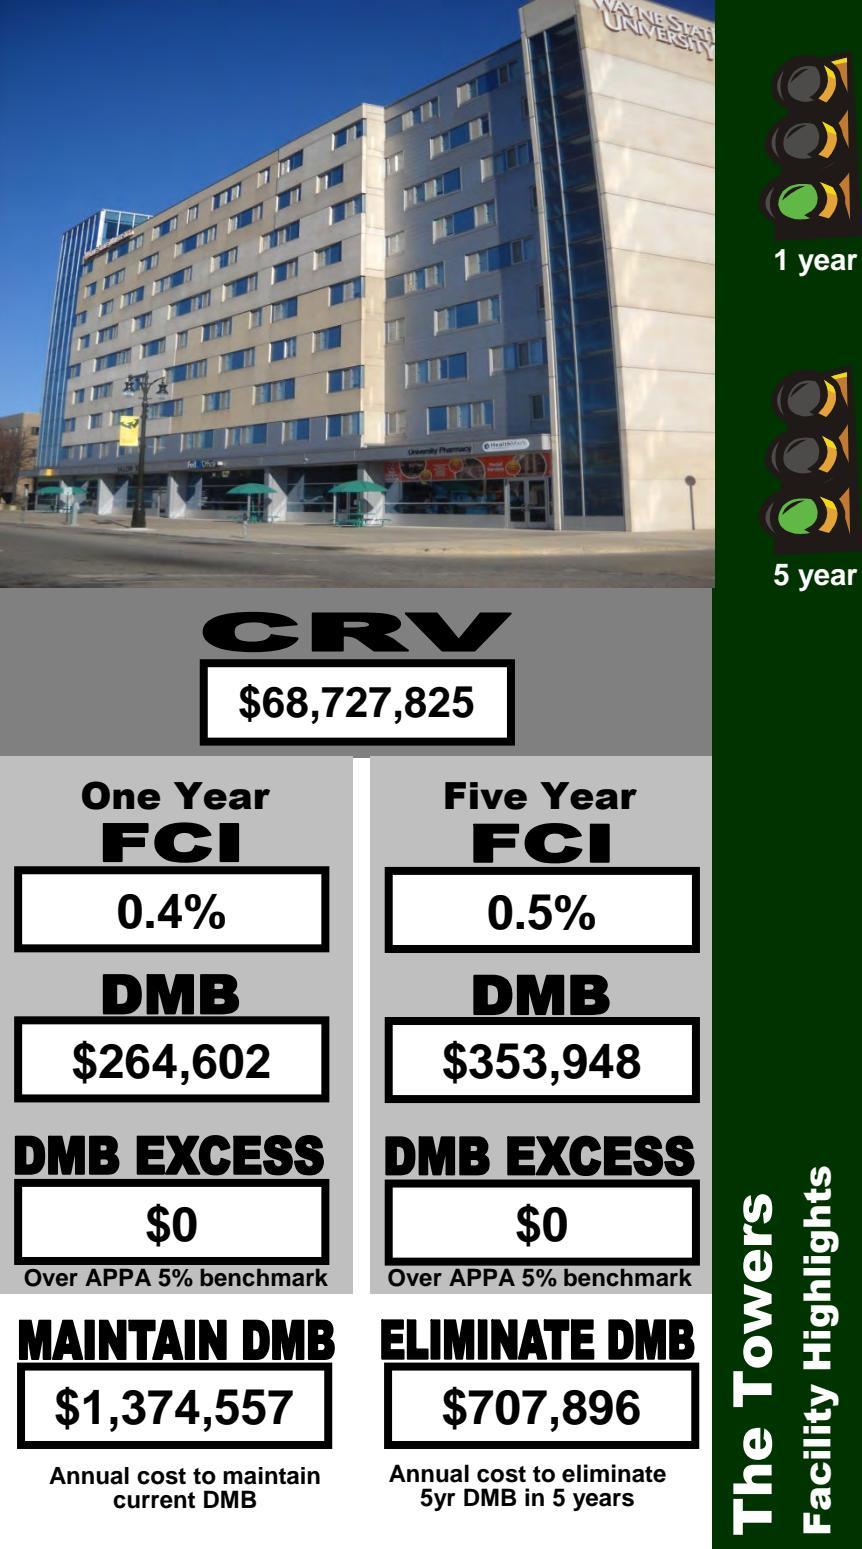
- The building envelope of glass, precast concrete panels, and metal panels are generally in good condition. Joint sealants are showing signs of deterioration though.
- Dishwashing Area does not have adequate exhaust to clear water vapor from space.
- Heat pumps provide heating/cooling in housing units.
- Elevator air conditioning condenser unit needs to be cleaned.
- Electrical Rooms are exhausted into Storage Rooms. Electrical Rooms are running hot; needs remediation.
- Non-weatherproof electrical transformer located in the Waste Area is exposed to hose water spray from trash operations.
- 120/208V electrical transformers need to be cleaned.
- Cooling tower fill needs replacement.
- Four emergency generators, in good condition, provide back-up power for Life Safety, Kitchen Coolers, and the Fire Pump.

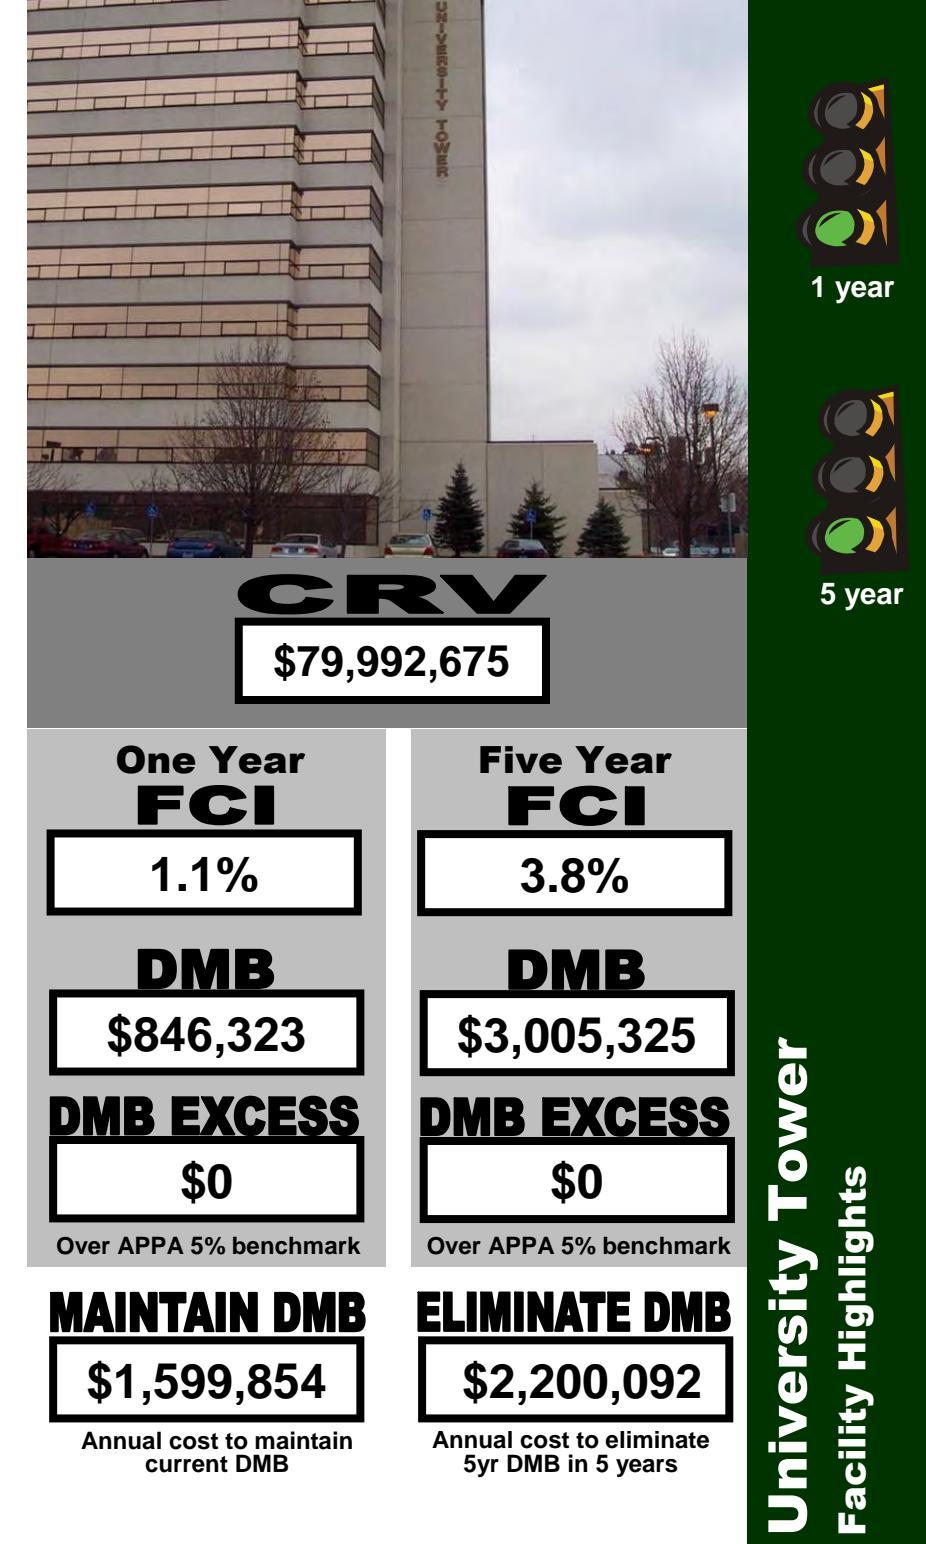
- Precast concrete exterior panels staining at joints & window framing, minor spalling at corners. Sealant cracking, leaking.
- Make-up air steam coil not functioning, due for immediate replacement.
- Corridor walls show abuse ongoing repair issue.
- Exterior door hardware wearing from high traffic replaced as required. Interior doors have lever hardware throughout.
- Corridor carpet showing excessive wear, fraying, buckling. Need complete replacement. 9th floor - trip hazard, replace immediately.
- New boiler plant built next to building provides steam for heat/water use.
- Heating hot water circulation pump motors are reaching the end of their useful service life.
- Temperature control compressed air lines are leaking enough to require the compressor to run most of the time.
- Cooling tower fill is in bad shape and needs replacement.

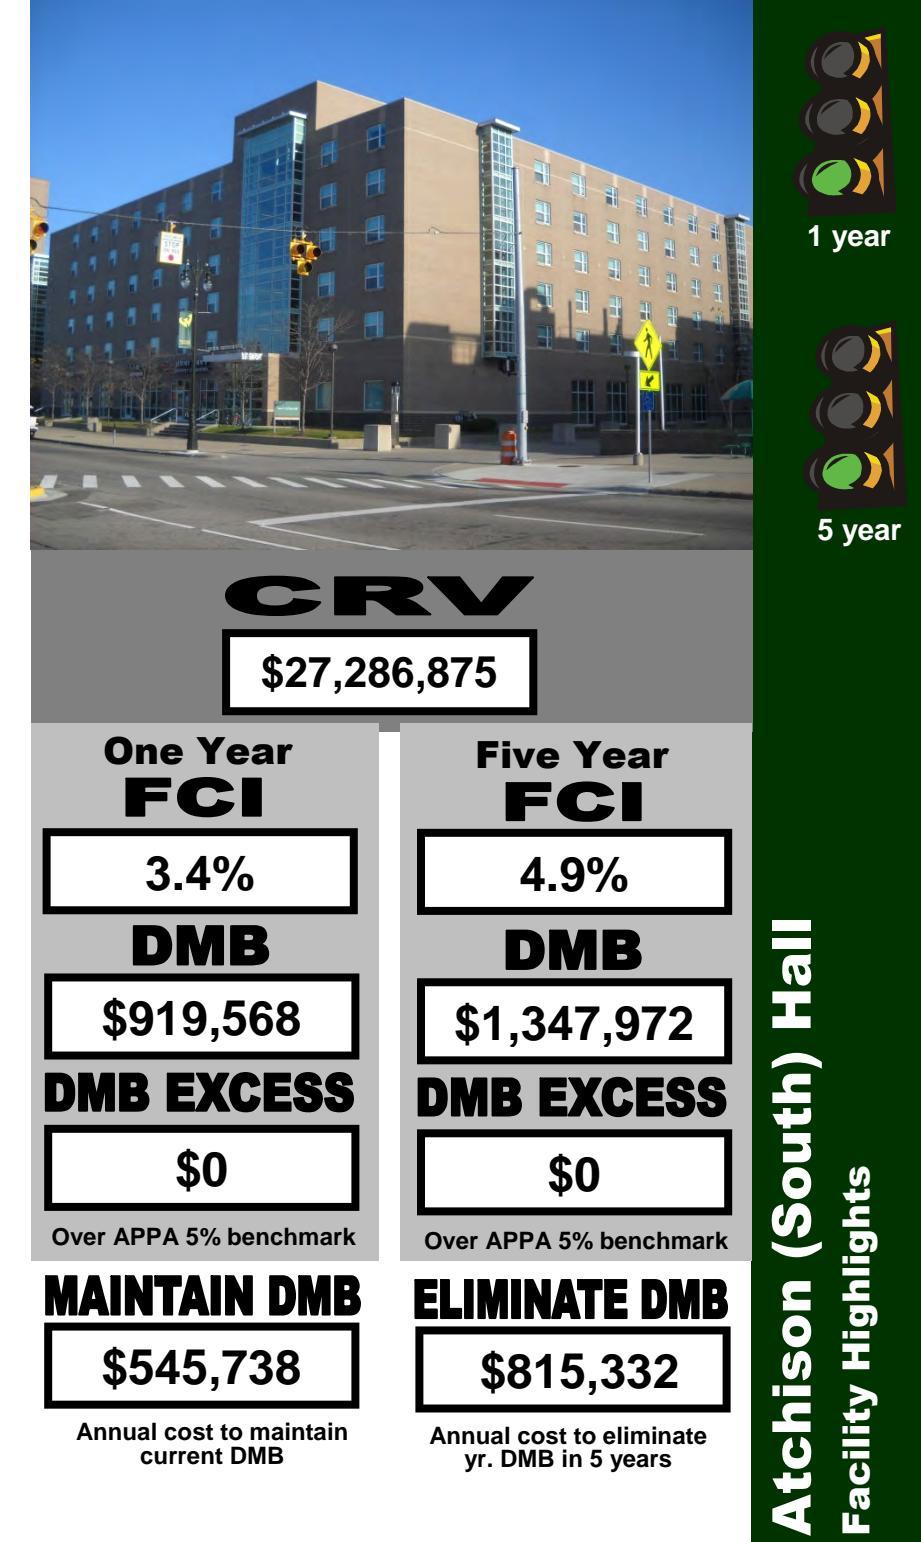
- The roof top make-up air units' gas burner flues need to be extended above the height of the alcove wall.
- A structural platform should be provided for service personnel at the make-up air units.
- Some exhaust fans were not running on the day of the observation.
- Exhaust was not working or not installed in many places that require exhaust. Janitor's closets were provided with exhaust; however, some fans were not working.
- Trash Compactor/recycle rooms, trash chute rooms, first level storage rooms, and common areas that have been provided with cooking equipment do not have any provisions for exhaust.

- Trash Compactor/recycle rooms, trash chute rooms, first level storage rooms, and common areas that have been provided with cooking equipment do not have any provisions for exhaust.
- The laundry room should be negatively pressurized to remove odors.
- The tenant fit-out area requires exhaust air control for both odors and generated heat.
- Numerous ceiling tiles are stained from condensate drainage piping from ceiling-mounted heat pumps.
- The electrical substation and room ventilation system needs to be cleaned.

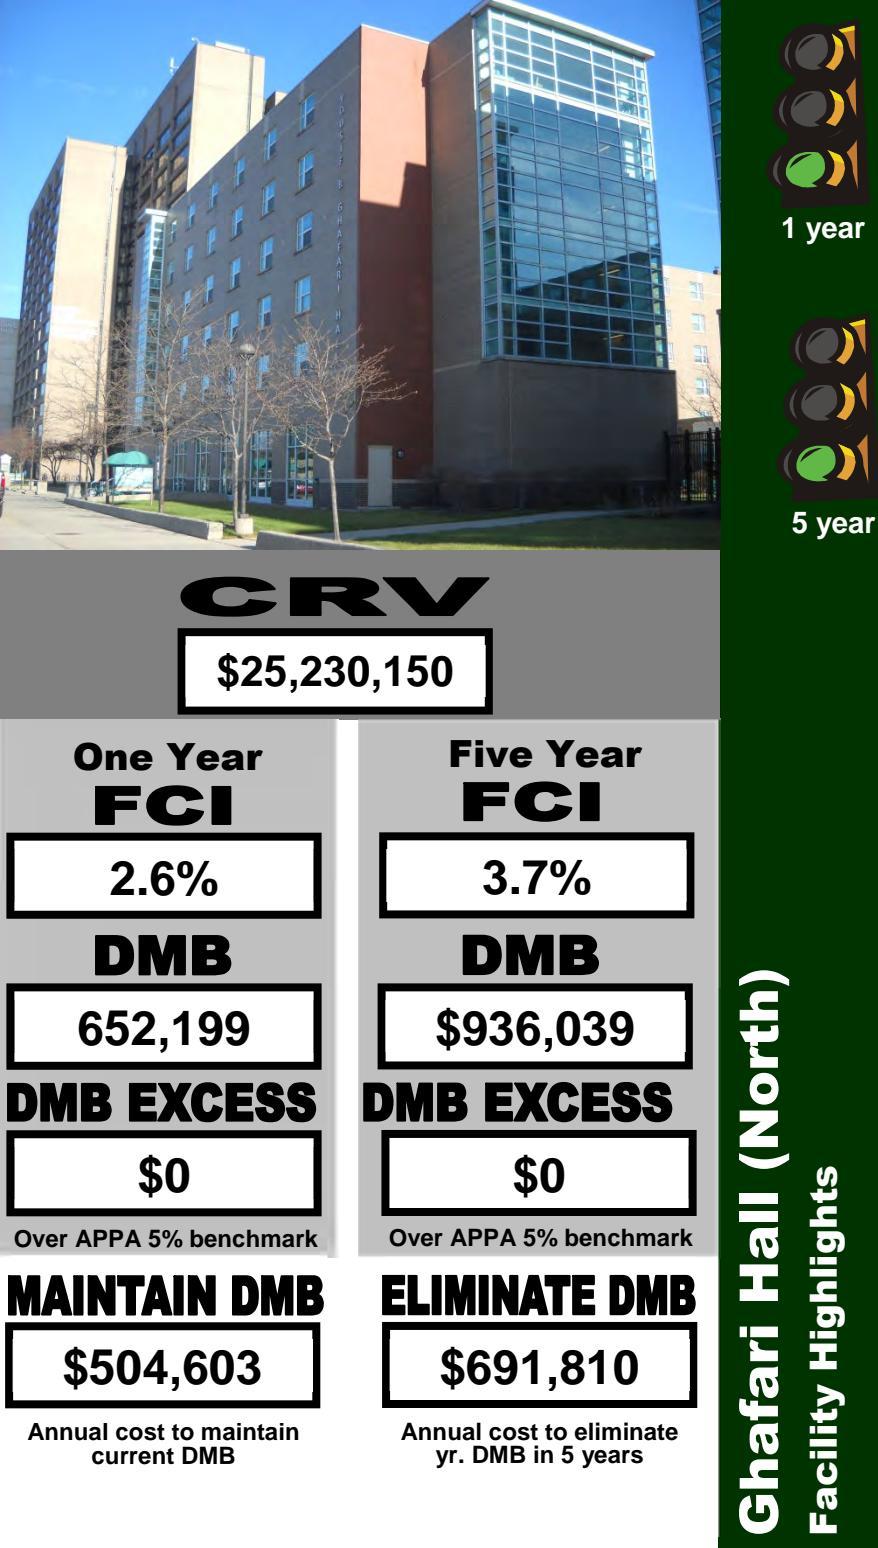
- Plumbing vents and exhaust sources of odor are closer than 10' to adjacent outdoor air intake hoods.
- Some condensate drain traps on roof top air handling equipment were PVC plastic piping and were broken.
- Exhaust was not working or not installed in many places that require exhaust (e.g. janitor's closets)
- Trash compactor/recycle rooms, trash chute rooms, first level storage rooms, and common areas with cooking equipment needs exhaust.
- The exhaust for laundry areas appears to be inadequate. Significant odors remain in the laundry room. Exhaust system should be provided.
- The tenant fit-out area does not have provisions for exhaust for both odors and generated heat.
- Loading areas/storage areas and vestibules with exterior exposures are protected by wet-pipe fire protection without adequate heat for freeze protection or the equipment was obstructed and rendered non-functional.

• Numerous ceiling tiles are stained from condensate drainage piping from ceiling-mounted heat pumps.
